# MARINE POLLUTION SURVEILLANCE REPORT

REPORT DATE: MARCH 20, 2015

Destroyed Taylor Platform :  
[ 28°56'9" N / 88°58'12" W ]
-

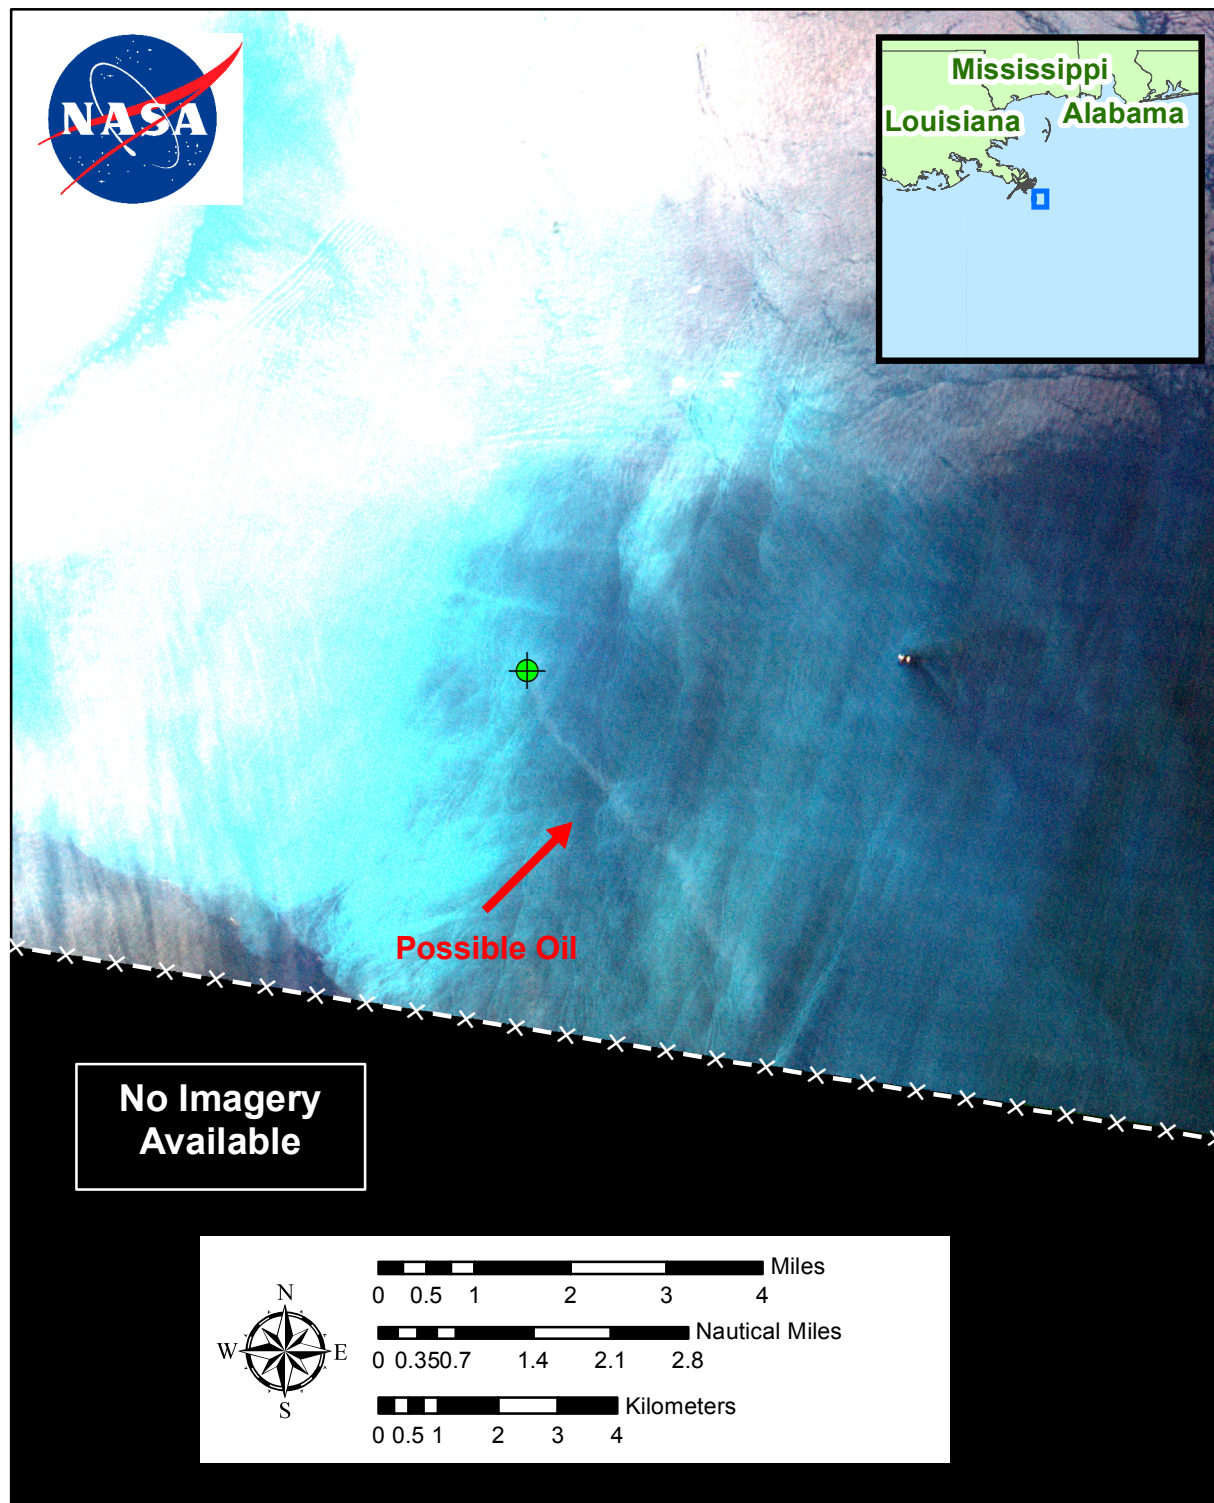
1.6 km<sup>2</sup> Area of Possible Oil

**CONFIDENCE: Medium-High**

Possible oil slick is observed extending southeast from a damaged oil facility. The slick is approximately 7km in length and 0.3km in width. The edges of the anomaly are not very sharp, due to enhancement of the image to make the oil better distinguished from the ocean background - And as such, it is possible that this is a conservative estimate of oil extent. No other uncertainties exist.
