# MARINE POLLUTION SURVEILLANCE REPORT

Analysis Provided by: The National Oceanic and  
Atmospheric Administration/National Environmental  
Satellite, Data and Information Service (NOAA/NESDIS)

REPORT DATE: MARCH 28, 2015  
REPORT TIME: 2230Z (1730 CDT)  
ANALYST: TURK

DATA SOURCE: LANDSAT-7 ETM+  
MODE: Multispectral  
RESOLUTION: 30 meter  
IMAGE DATE/TIME: 3/28/2015 1625Z (1125 CDT)

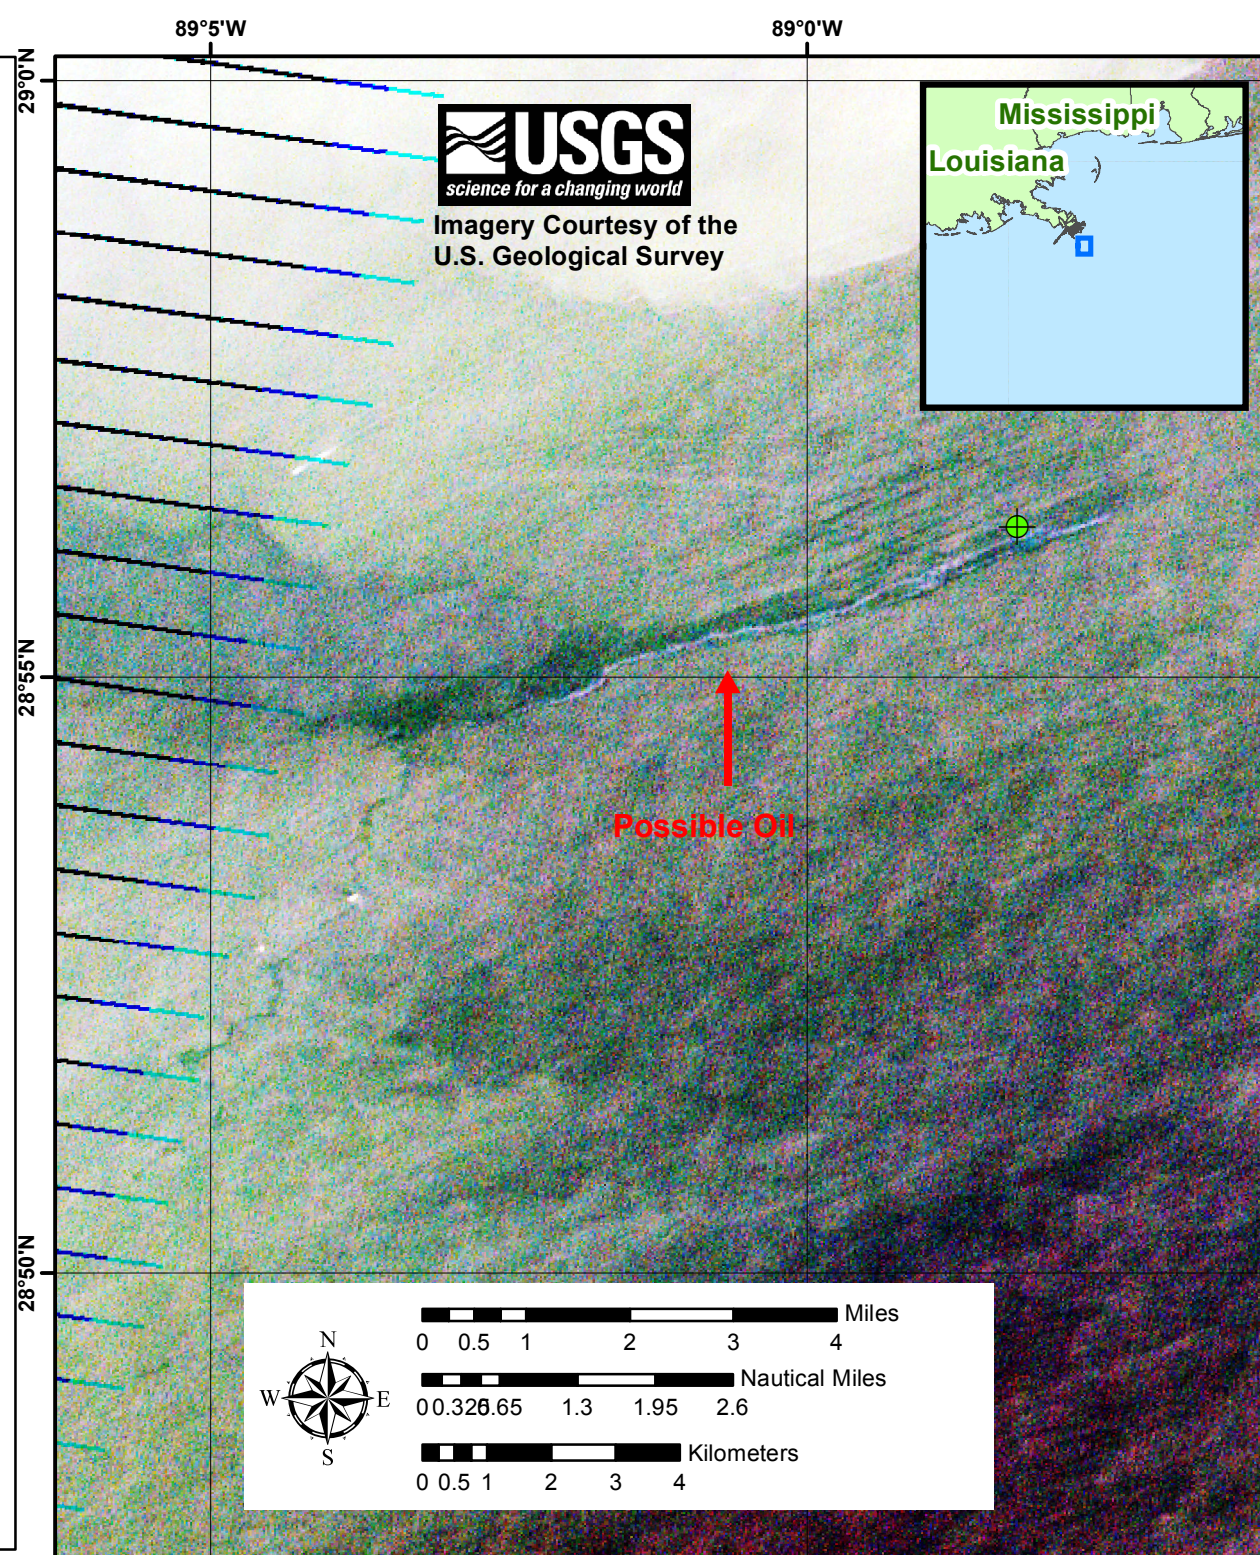
Destroyed Taylor Platform :  
[ 28°56'9" N / 88°58'12" W ]
-

8.7 km² Area of Possible Oil

**CONFIDENCE: High**

Oil from the destroyed Taylor platform extends 6.8 miles  
from east-northeast to west-southwest in this enhanced  
Landsat-8 image taken at 1625Z. The slick was up to 0.6  
miles wide.

Sky conditions were clear and winds were from the east-  
northeast at 10-15 knots at the time the image was  
taken.
