MARINE POLLUTION SURVEILLANCE REPORT

Analysis Provided by: The National Oceanic and
Atmospheric Administration/National Environmental
Satellite, Data and Information Service (NOAA/NESDIS)

REPORT DATE: MAY 06, 2015
REPORT TIME: 2030Z (1530 CDT)
ANALYST: KEMAL

DATA SOURCE: TERRA MODIS
MODE: Multispectral
RESOLUTION: 250 meter
IMAGE DATE/TIME: 5/6/2015 1650Z (1150 CDT)

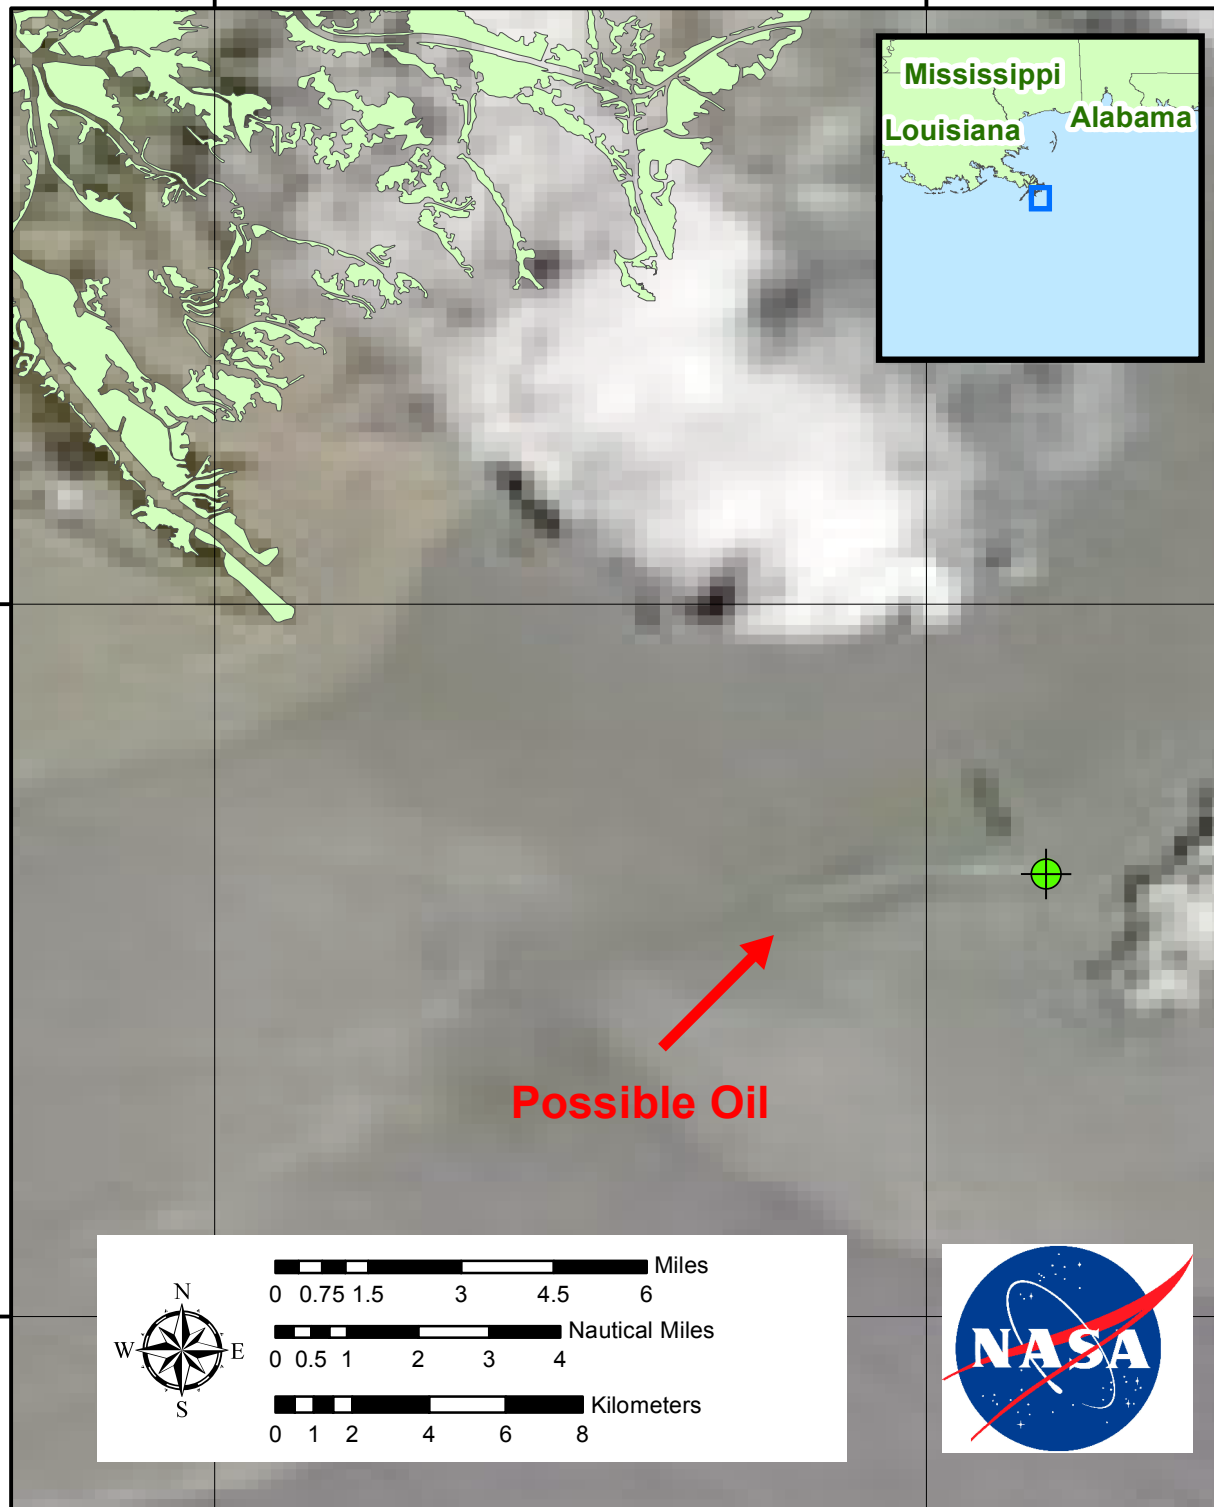
Destroyed Taylor Platform :
[28°56'9" N / 88°58'12" W]
-

2.8 km² Area of Possible Oil

CONFIDENCE: High

An oil slick extended for 3.4 miles to the west of the destroyed Taylor Platform. The slick was up to 0.56 miles wide. Sky conditions were mostly clear and winds were easterly winds at 15 knots at the time of the image. Ocean currents were consistent with the orientation of the slick as well. The slick was approximately 8 miles off shore.
