# MARINE POLLUTION SURVEILLANCE REPORT

Analysis Provided by: The National Oceanic and  
Atmospheric Administration/National Environmental  
Satellite, Data and Information Service (NOAA/NESDIS)

REPORT DATE: MAY 23, 2015  
REPORT TIME: 2050Z (1550 CDT)  
ANALYST: TURK

DATA SOURCE: AQUA MODIS  
MODE: Multispectral  
RESOLUTION: 250 meter  
IMAGE DATE/TIME: 5/23/2015 1905Z (1405 CDT)

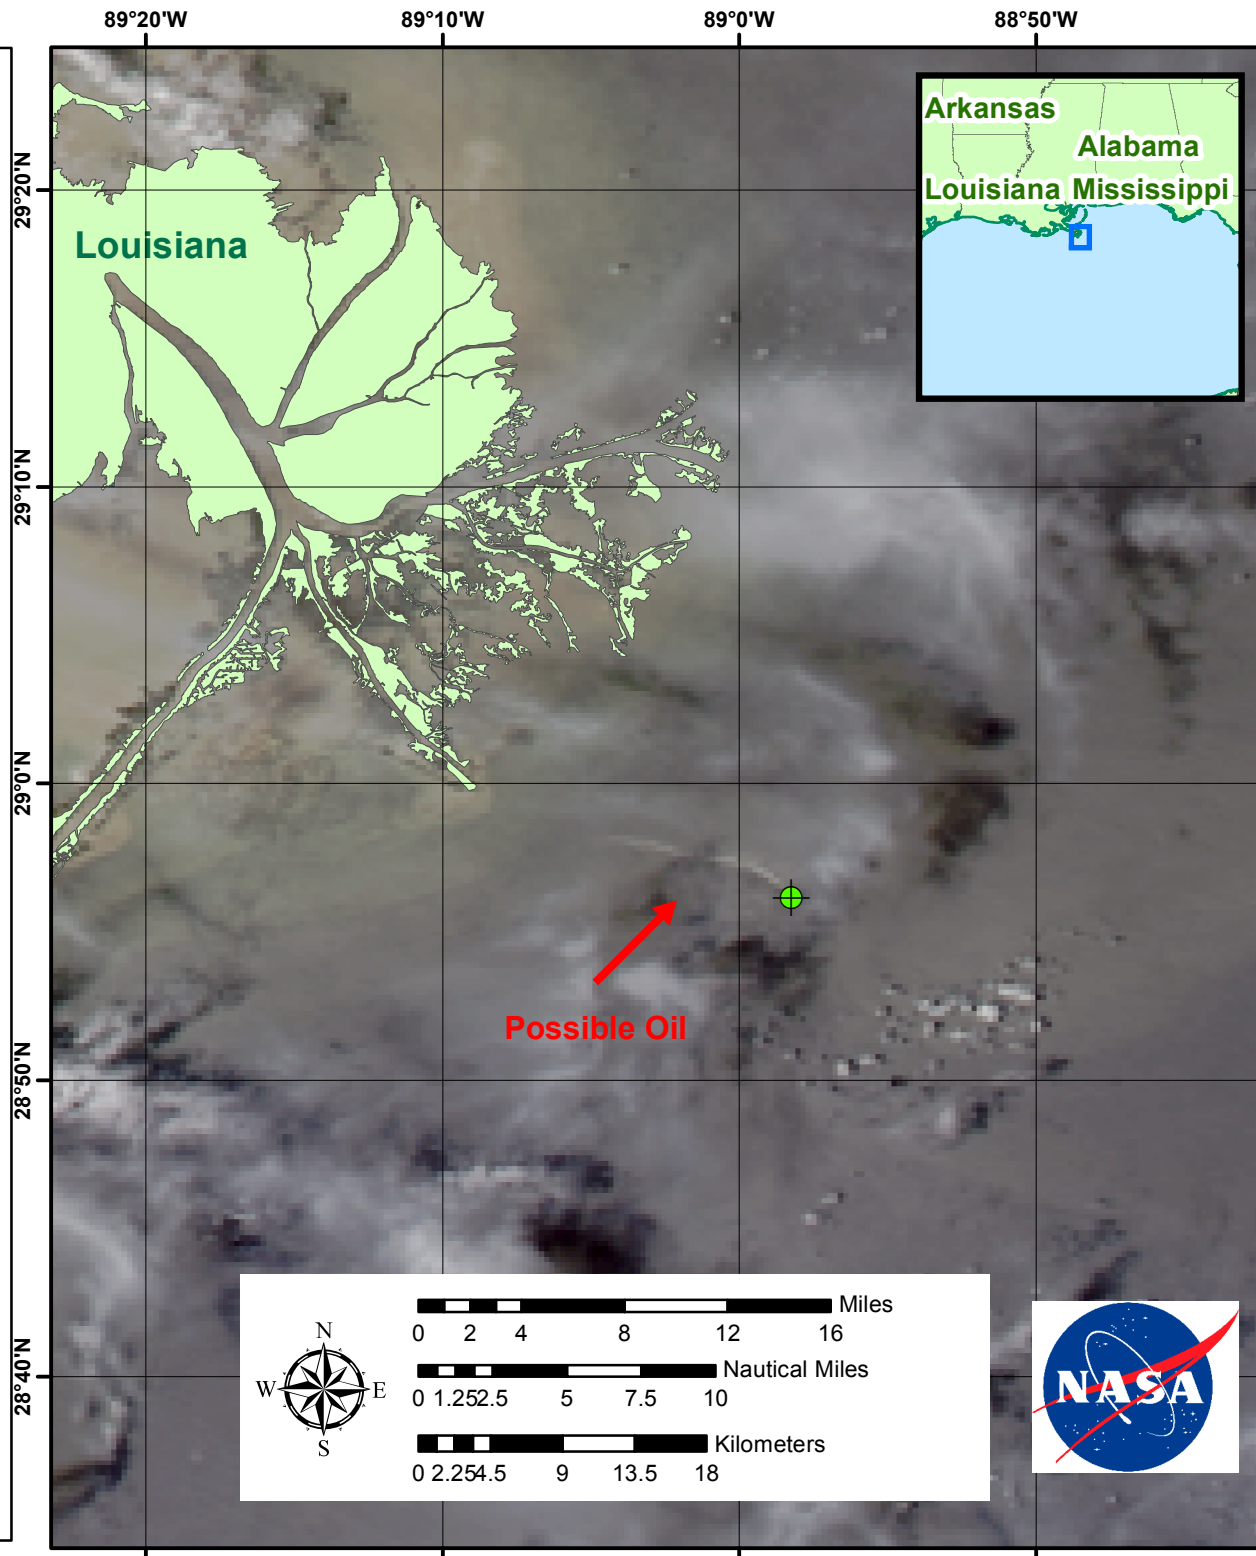
14.4 km<sup>2</sup> Area of Possible Oil

**CONFIDENCE: High**

An oil slick from the destroyed Taylor platform extended  
6.6 miles to the west and was up to 0.7 miles wide.

Skies were partly cloudy at the time of the image and  
winds were from the east at 10-15 knots.
