MARINE POLLUTION SURVEILLANCE REPORT

Analysis Provided by: The National Oceanic and
Atmospheric Administration/National Environmental
Satellite, Data and Information Service (NOAA/NESDIS)

REPORT DATE: MAY 24, 2015

Destroyed Taylor Platform :
[28°56'9" N / 88°58'12" W]
-

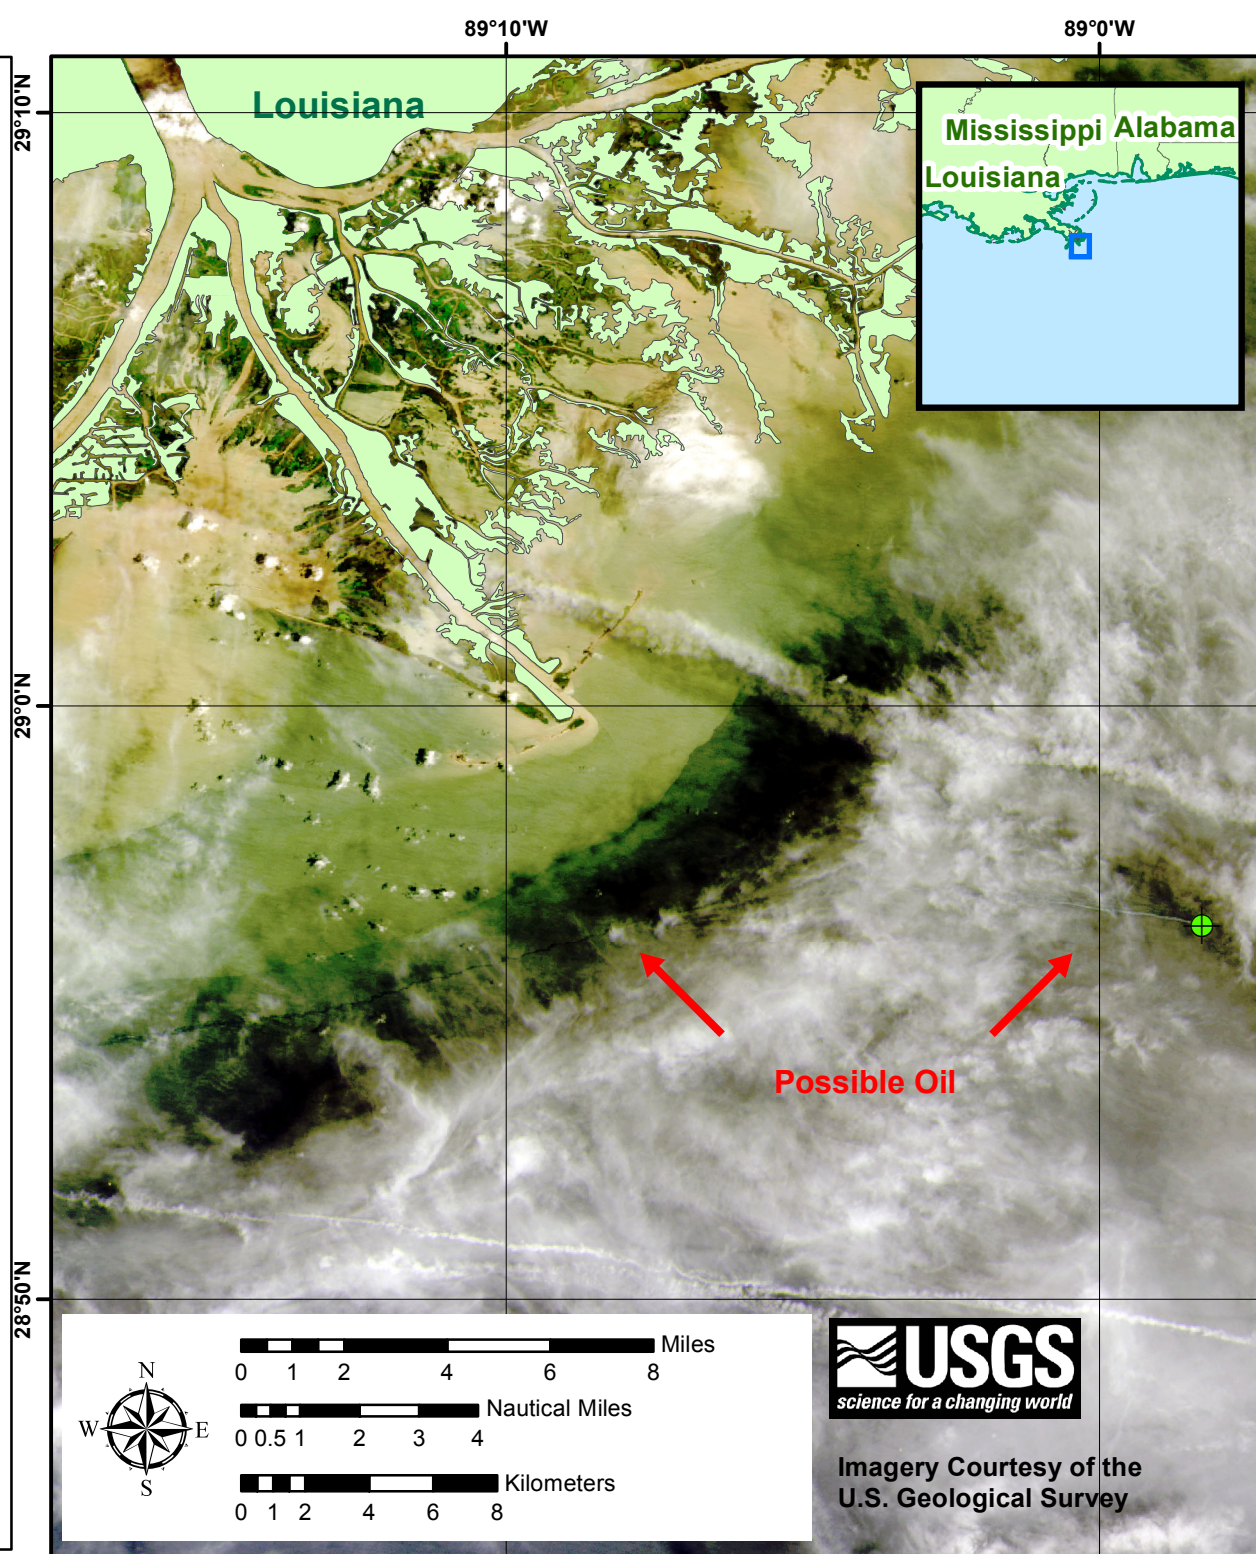
Area of Possible Oil

A narrow oil slick was detected extending west from the destroyed Taylor platform. Although cloud cover prevented a complete analysis, the implied length of the anomaly was at least 19.1 miles, which was in reasonable agreement with the 23 mile slick described in Incident Report #1117350 from today, 5/23.

Sky conditions were mostly cloudy at the time of the image and winds were from the east at 10-15 knots.
