MARINE POLLUTION SURVEILLANCE REPORT

Analysis Provided by: The National Oceanic and
Atmospheric Administration/National Environmental
Satellite, Data and Information Service (NOAA/NESDIS)

REPORT DATE: MAY 31, 2015
REPORT TIME: 0715Z (0215 CDT)
ANALYST: TURK

DATA SOURCE: LANDSAT-8 OLI
MODE: Multispectral
RESOLUTION: 30 meter
IMAGE DATE/TIME: 5/30/2015 1631Z (1131 CDT)

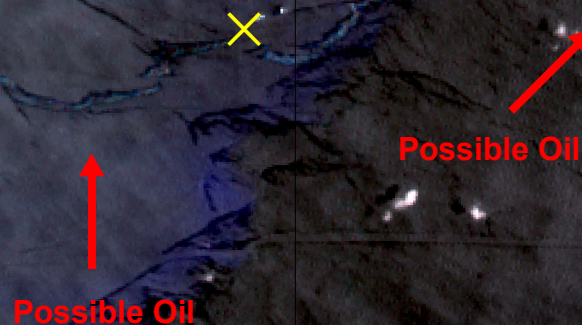
REMARKS: Incident Rprt #1118047 taken at 30/1430Z indicated an unknown sheen of faint colors 1.5 miles in length moving toward the northwest.

It is believed that that unknown sheen is seen in the eastern portion of a larger anomaly detected in this 30/1631Z Landsat-8 image. The anomaly is broken and stretches approximately 7.5 miles from east to west. Portions of the anomaly that were shimmering and rainbow in appearance were drawn here, but the anomaly could be larger.

Winds were from the east at 5-10 knots at the time of the image and skies were generally clear.

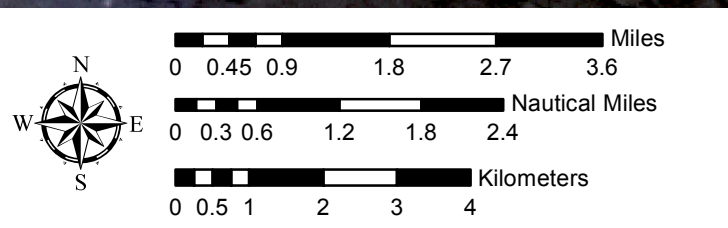
Center Point of Oil Slick:
[28°58'26" N / 90°50'24" W]
-
