MARINE POLLUTION SURVEILLANCE REPORT

Analysis Provided by: The National Oceanic and
Atmospheric Administration/National Environmental
Satellite, Data and Information Service (NOAA/NESDIS)

REPORT DATE: MAY 31, 2015
REPORT TIME: 0800Z (0300 CDT)
ANALYST: TURK

DATA SOURCE: LANDSAT-8 OLI
MODE: Multispectral
RESOLUTION: 30 meter
IMAGE DATE/TIME: 5/30/2015 1631Z (1131 CDT)

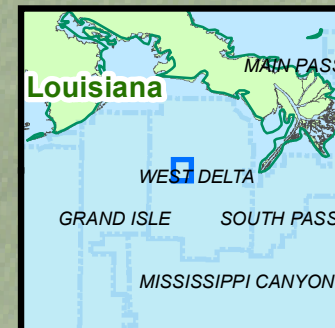
.2 km² Area of Possible Oil

CONFIDENCE: Medium-High

A possible broken oil slick extended 1.7 miles to the west
of an oil facility. The slick was up to 0.1 mile wide.

Winds were from the east at 5-10 knots at the time of the
image and skies were clear.
