# MARINE POLLUTION SURVEILLANCE REPORT

REPORT DATE: MAY 31, 2015  
REPORT TIME: 2315Z (1815 CDT)  
ANALYST: KEMAL

DATA SOURCE: LANDSAT-7 ETM+  
MODE: Multispectral  
RESOLUTION: 30 meter  
IMAGE DATE/TIME: 5/31/2015 1625Z (1125 CDT)

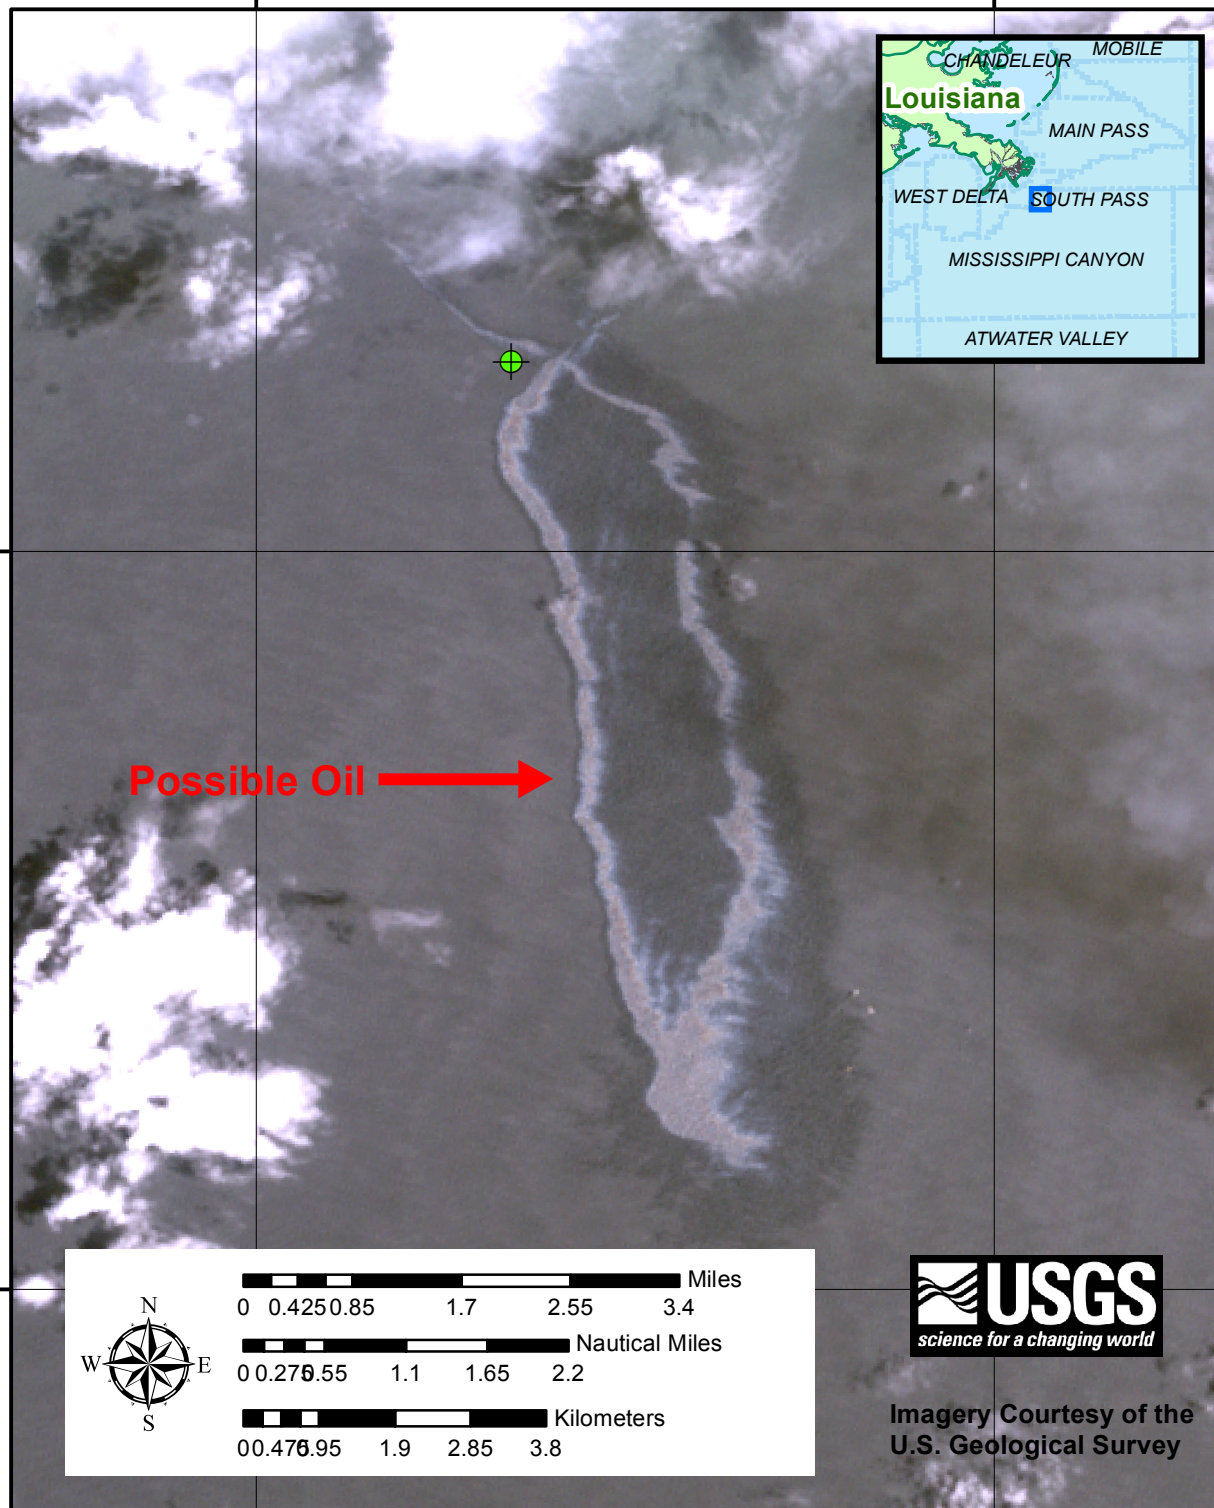
Area of Possible Oil

**CONFIDENCE: High**

The oil slick appears to be coming from the destroyed Taylor Platform. The oil slick is 7.76 miles in length and at its widest point it is 0.67 miles. The winds were from 5-10 knots at the time of the image and sky conditions were partly cloudy and can not identify how far North the slick extends.
