MARINE POLLUTION SURVEILLANCE REPORT

Analysis Provided by: The National Oceanic and
Atmospheric Administration/National Environmental
Satellite, Data and Information Service (NOAA/NESDIS)

REPORT DATE: OCTOBER 15, 2015

IMAGE DATE/TIME: 10/14/2015 1626Z (1126 CDT)

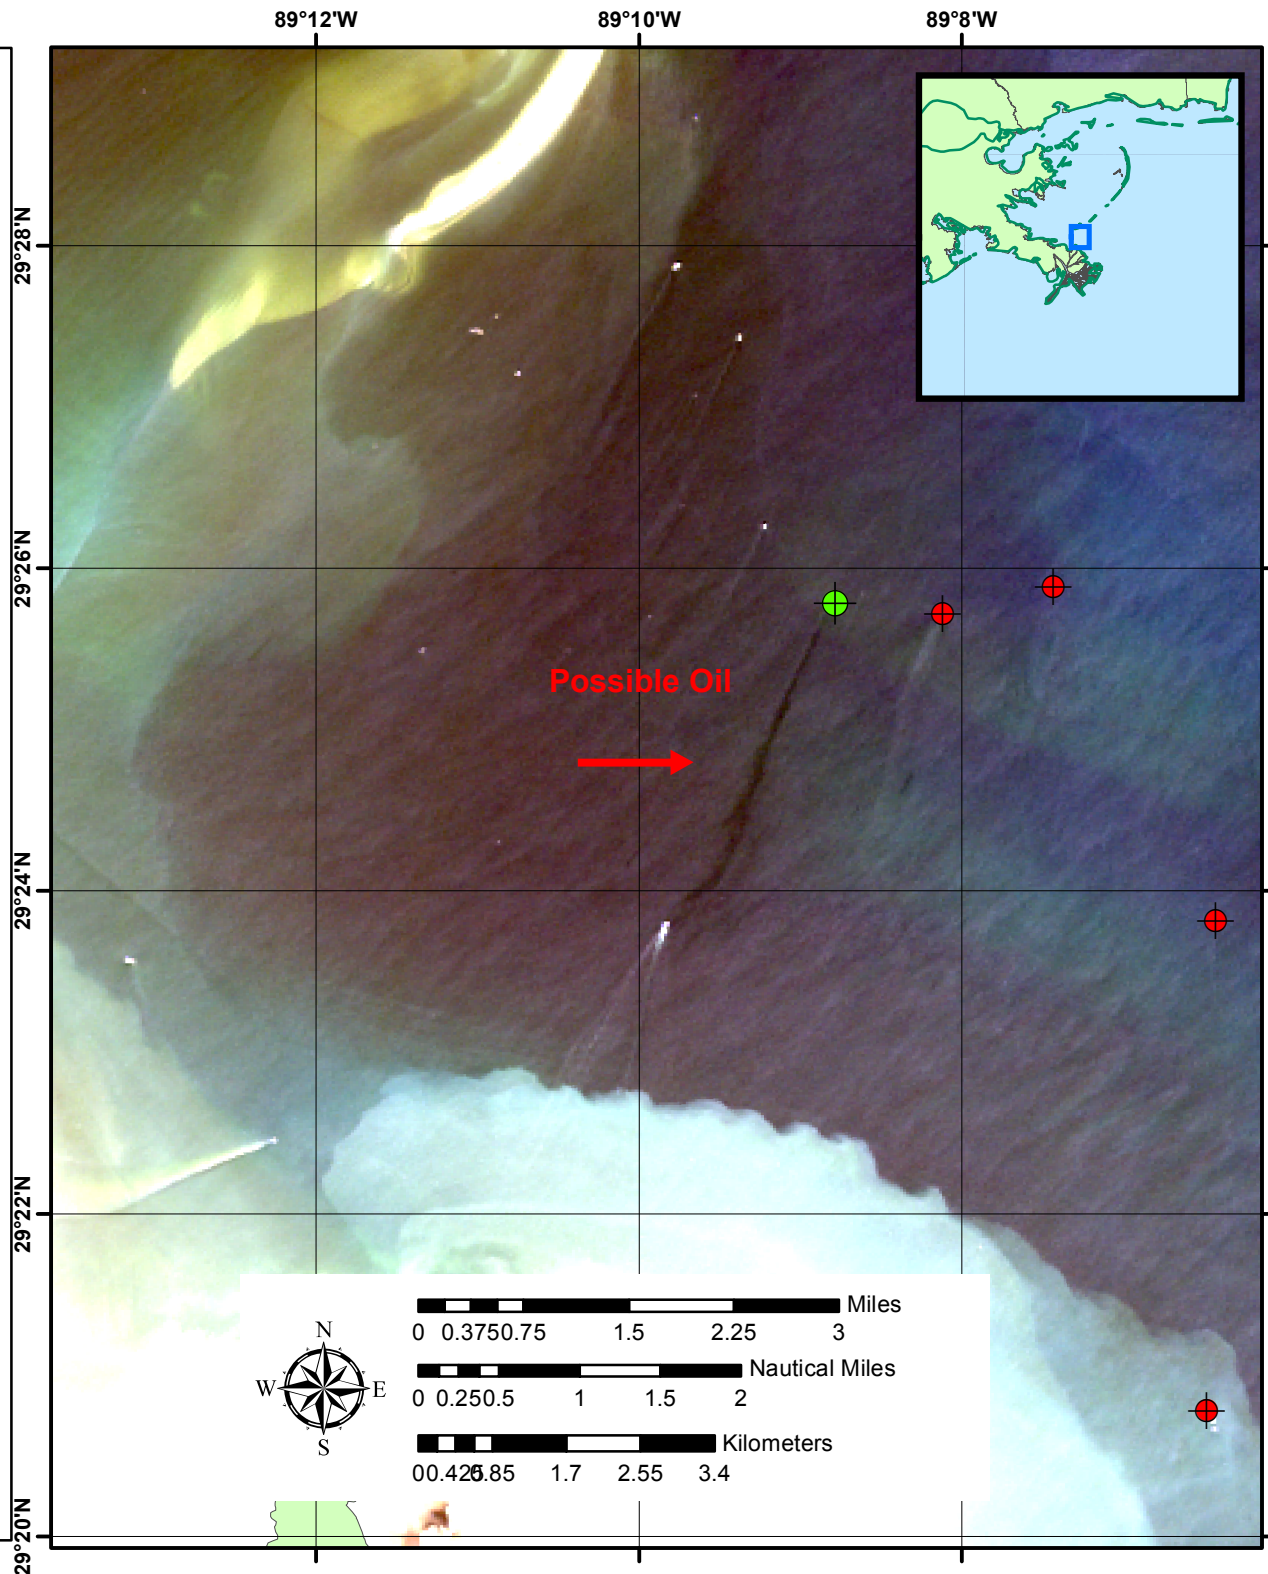
.6 km² Area of Possible Oil

CONFIDENCE: Low

A 2.3 mile long anomaly that was up to 0.1 mile long extended to the southwest of a point source that could not be positively identified as an oil production facility, but a pipeline emanates from this location. Confidence is low because the nature of the point source is ambiguous.

Skies were clear and winds were from the north at 10-15 knots at the time of the image.
