MARINE POLLUTION SURVEILLANCE REPORT

Analysis Provided by: The National Oceanic and
Atmospheric Administration/National Environmental
Satellite, Data and Information Service (NOAA/NESDIS)

REPORT DATE: FEBRUARY 24, 2018
REPORT TIME: 2320Z (1720 CST)
ANALYST: WHISNANT

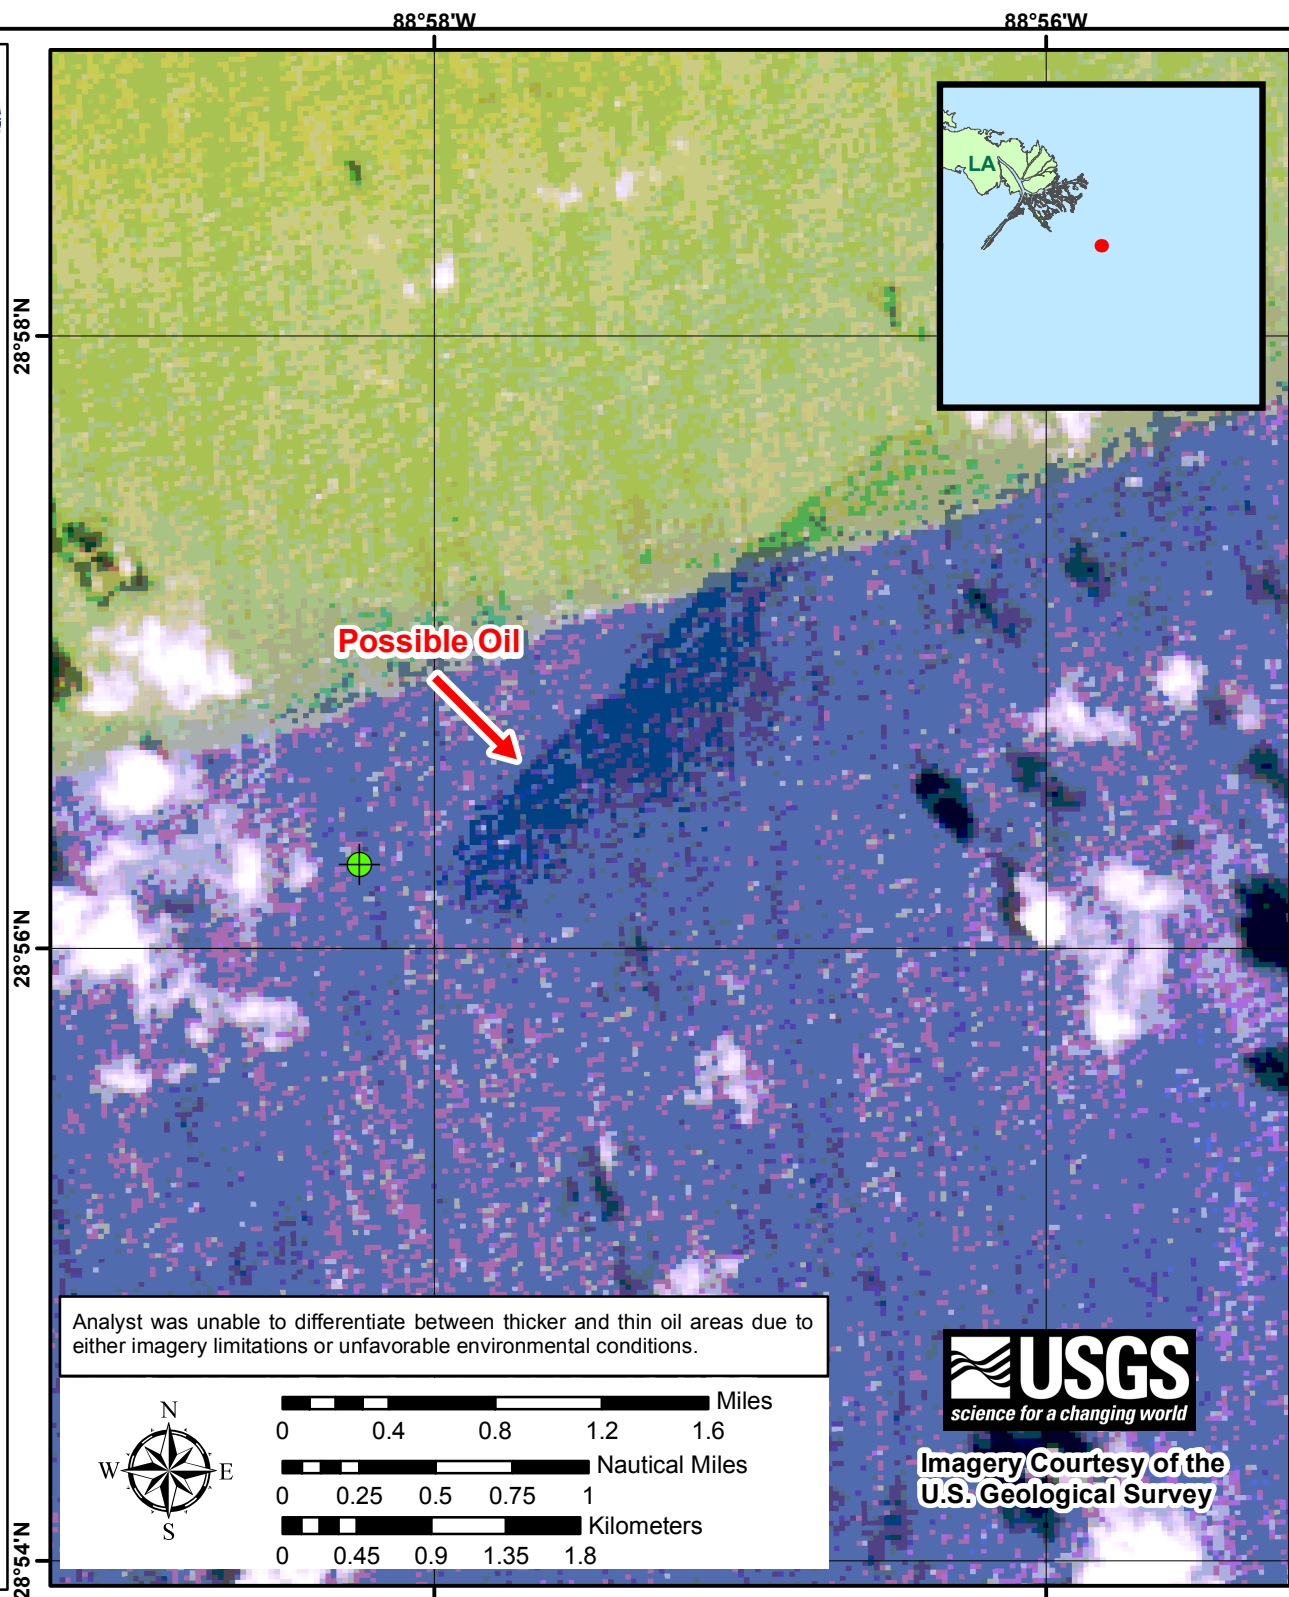
-   Possible Oil
-   Possible Thicker Oil
-   Destroyed Taylor Platform :
[28°56'09" N / 88°58'12" W]
-   2.7 km² Area of Possible Oil
-   False Positive (not oil)

Satellite imagery revealed an anomaly believed to be oil just east of the Destroyed Taylor Platform. The anomaly showed mostly good contrast with its surroundings and appeared out of place. The anomaly stretched a total of 2.11 nautical miles in the southwest-northeast orientation. Surface winds around the time of the image were from the South at 10-15 knots. Confidence is determined to be Medium-High given the anomaly is not directly attached the known repeat leak source and shows lesser contrast at its northeastern edge.
