MARINE POLLUTION SURVEILLANCE REPORT

Analysis Provided by: The National Oceanic and
Atmospheric Administration/National Environmental
Satellite, Data and Information Service (NOAA/NESDIS)

REPORT DATE: SEPTEMBER 7, 2012
REPORT TIME: 2145Z (1645 CDT)
ANALYST: SHEFFLER

DATA SOURCE: LANDSAT-7
MODE: MULTI-SPECTRAL
RESOLUTION: 30 METER
IMAGE DATE/TIME: 9/7/2012 1646Z (9/7/12 1146 CDT)

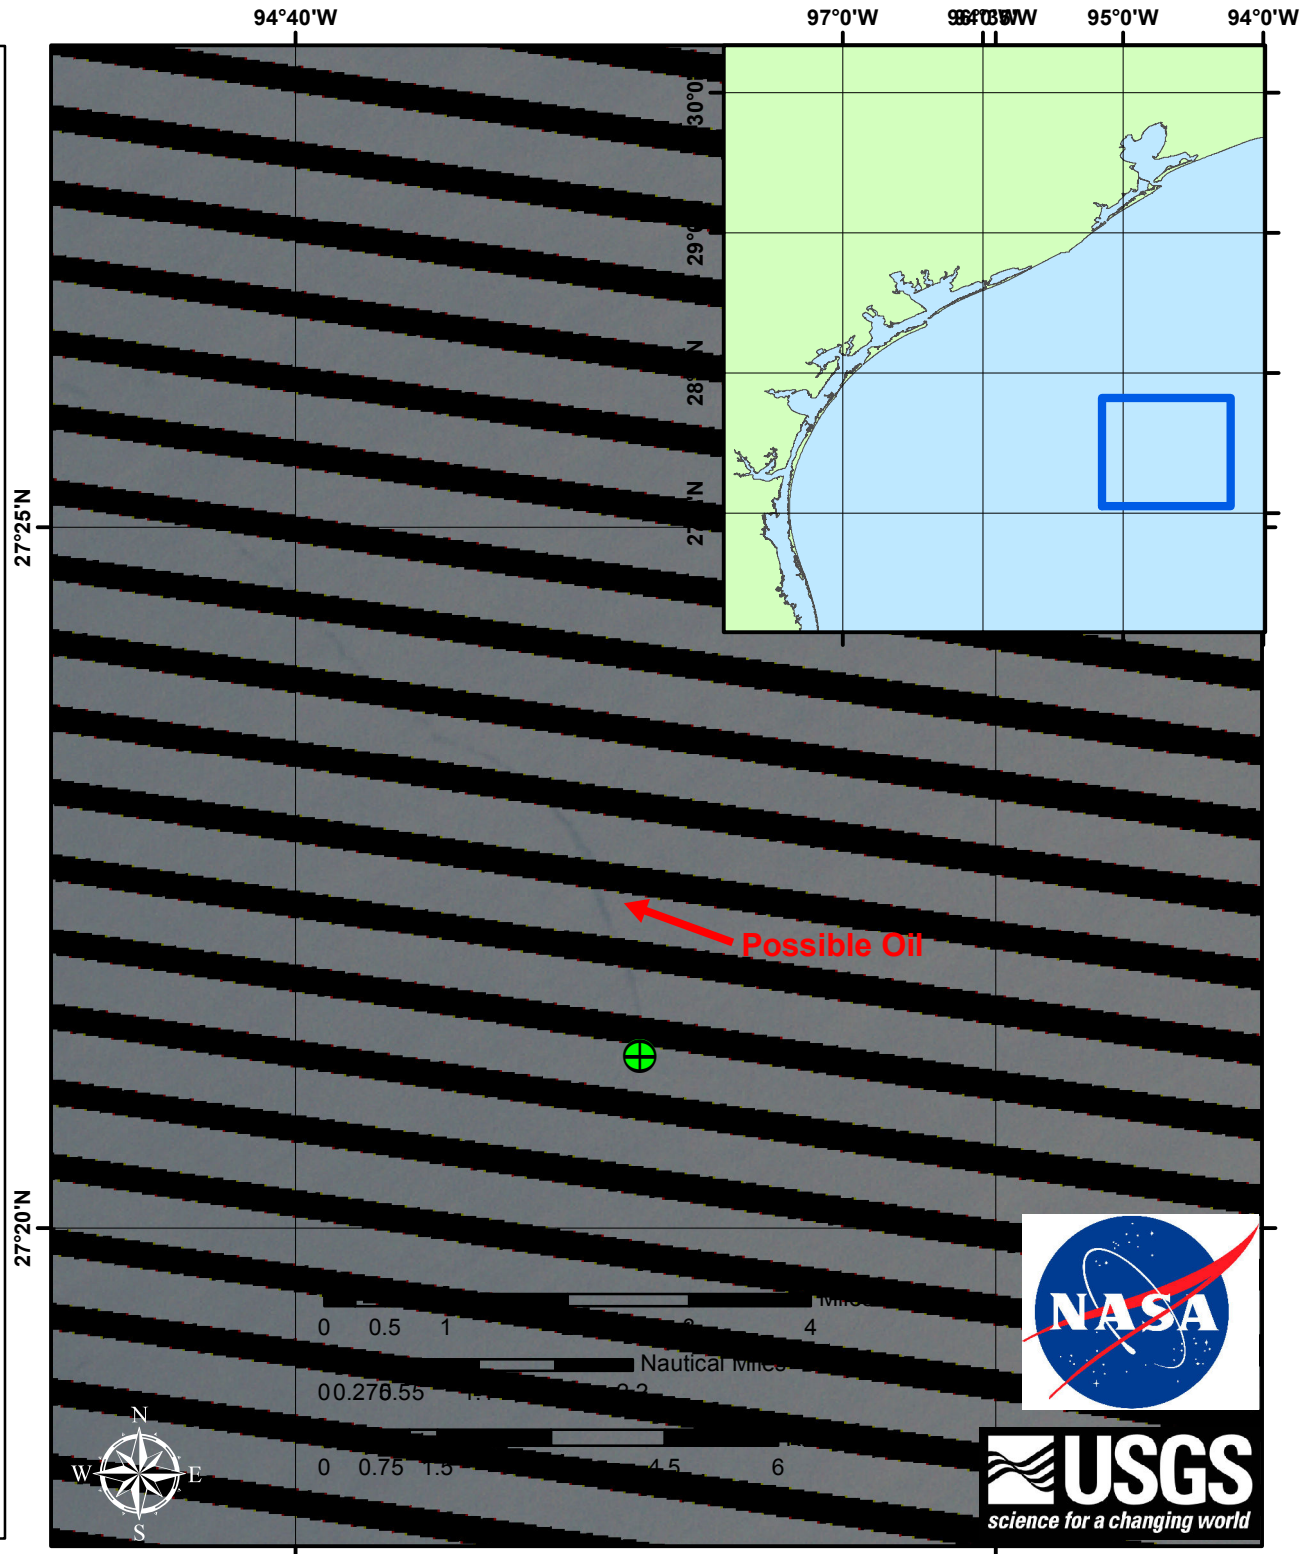
Suspected Point Source:
[27°21'14" N / 94°37'33" W]

A thin plume of suspected oil is seen in this image coming from a suspected point source in the western Gulf of Mexico. It is located approximately 133 miles south of Galveston, TX and 174 miles east of Corpus Christi, TX. The slick extended about 5.25 miles northwest from the source point and was 0.1 mile or less in width. Skies were mostly cloud free at the time of the image with light winds from the southwest.
