MARINE POLLUTION SURVEILLANCE REPORT

Analysis Provided by: The National Oceanic and
Atmospheric Administration/National Environmental
Satellite, Data and Information Service (NOAA/NESDIS)

REPORT DATE: JUNE 01, 2013
REPORT TIME: 1843Z (1343 CDT)
ANALYST: WARREN

Destroyed Taylor Platform :
[28°56'9" N / 88°58'12" W]
-

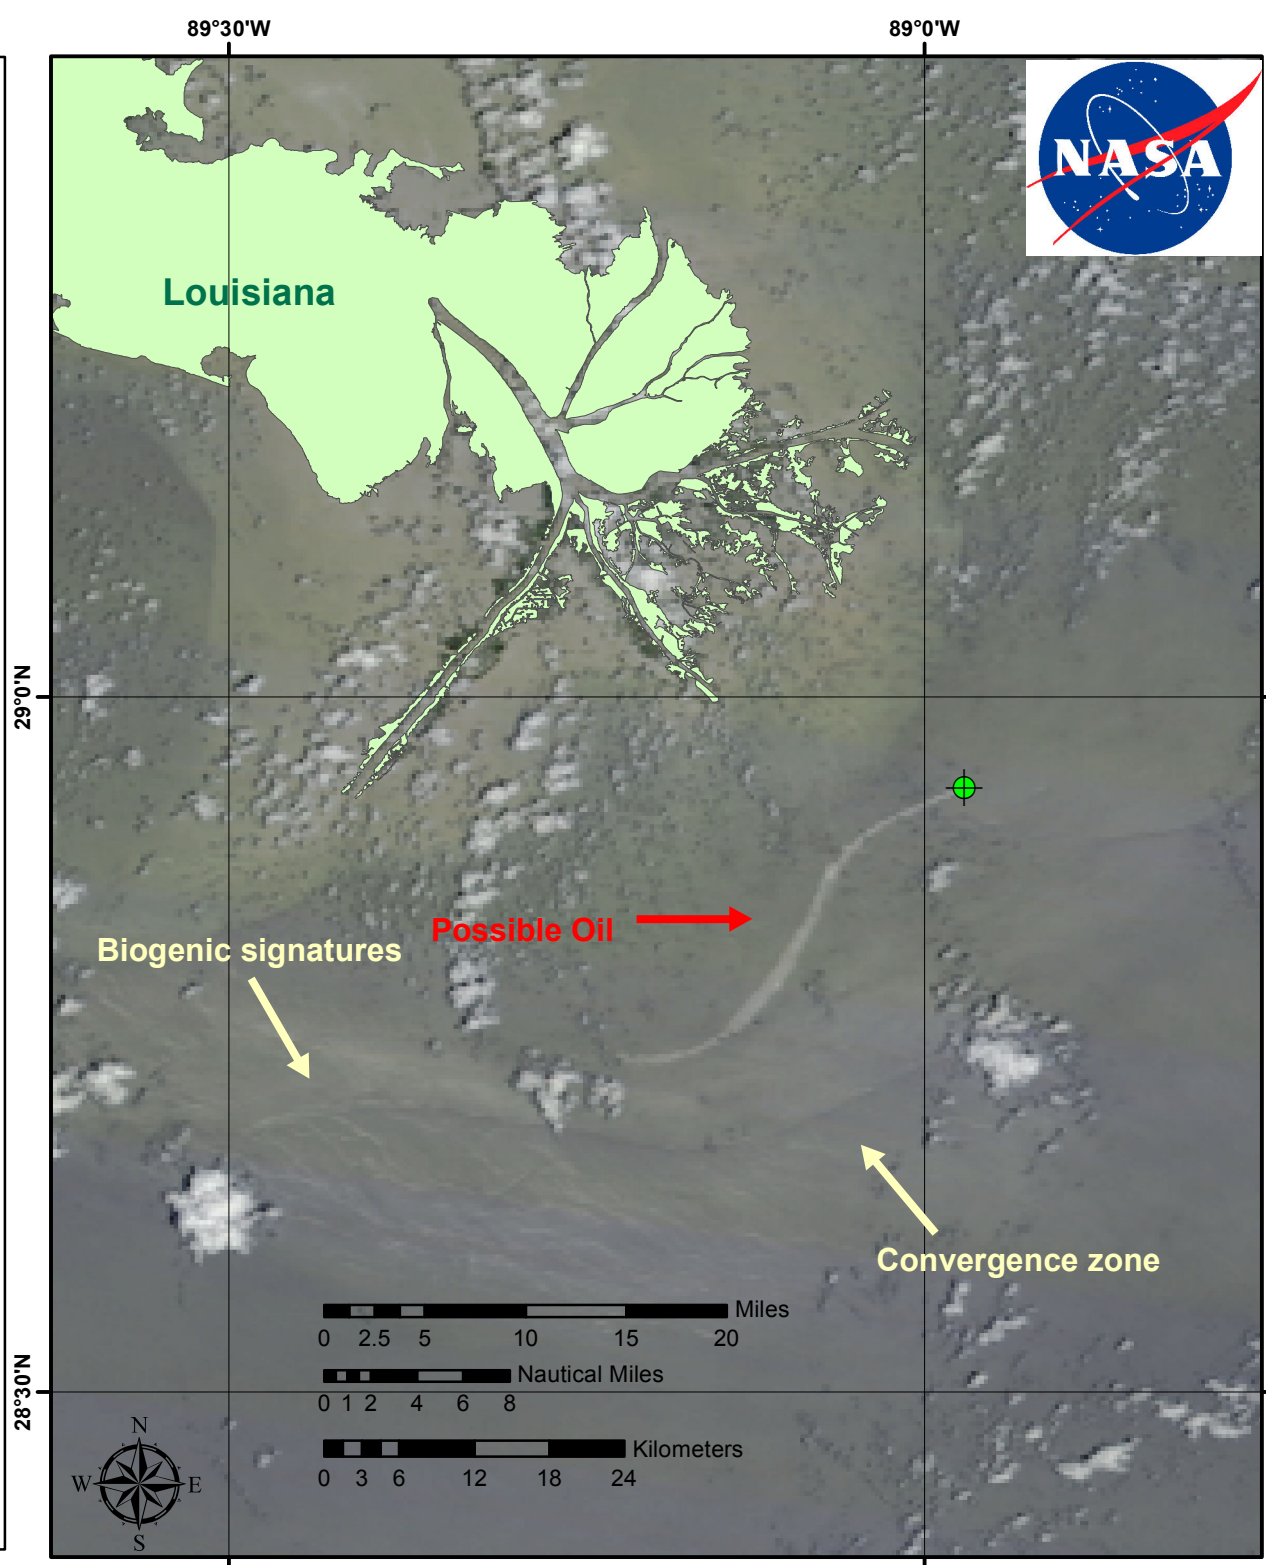
39 km² Area of Possible Oil

Well-defined oil sheen stretching southwest of the destroyed Taylor site this afternoon. Oil sheen orientation matches well with forecast ocean currents which actually show a speed maximum collocated with sheen's location. Surface winds are from the south and helping to feather the oil somewhat toward the north. Sheen is approximately 20.2 miles long by 1.0 mile wide per satellite analysis.
