# MARINE POLLUTION SURVEILLANCE REPORT

REPORT DATE: MAY 08, 2013  
REPORT TIME: 2239Z (1739 CDT)  
ANALYST: TURK

DATA SOURCE: AQUA MODIS  
MODE: Multispectral  
RESOLUTION: 250 meter  
IMAGE DATE/TIME: 5/8/2013 1910Z (1410 CDT)

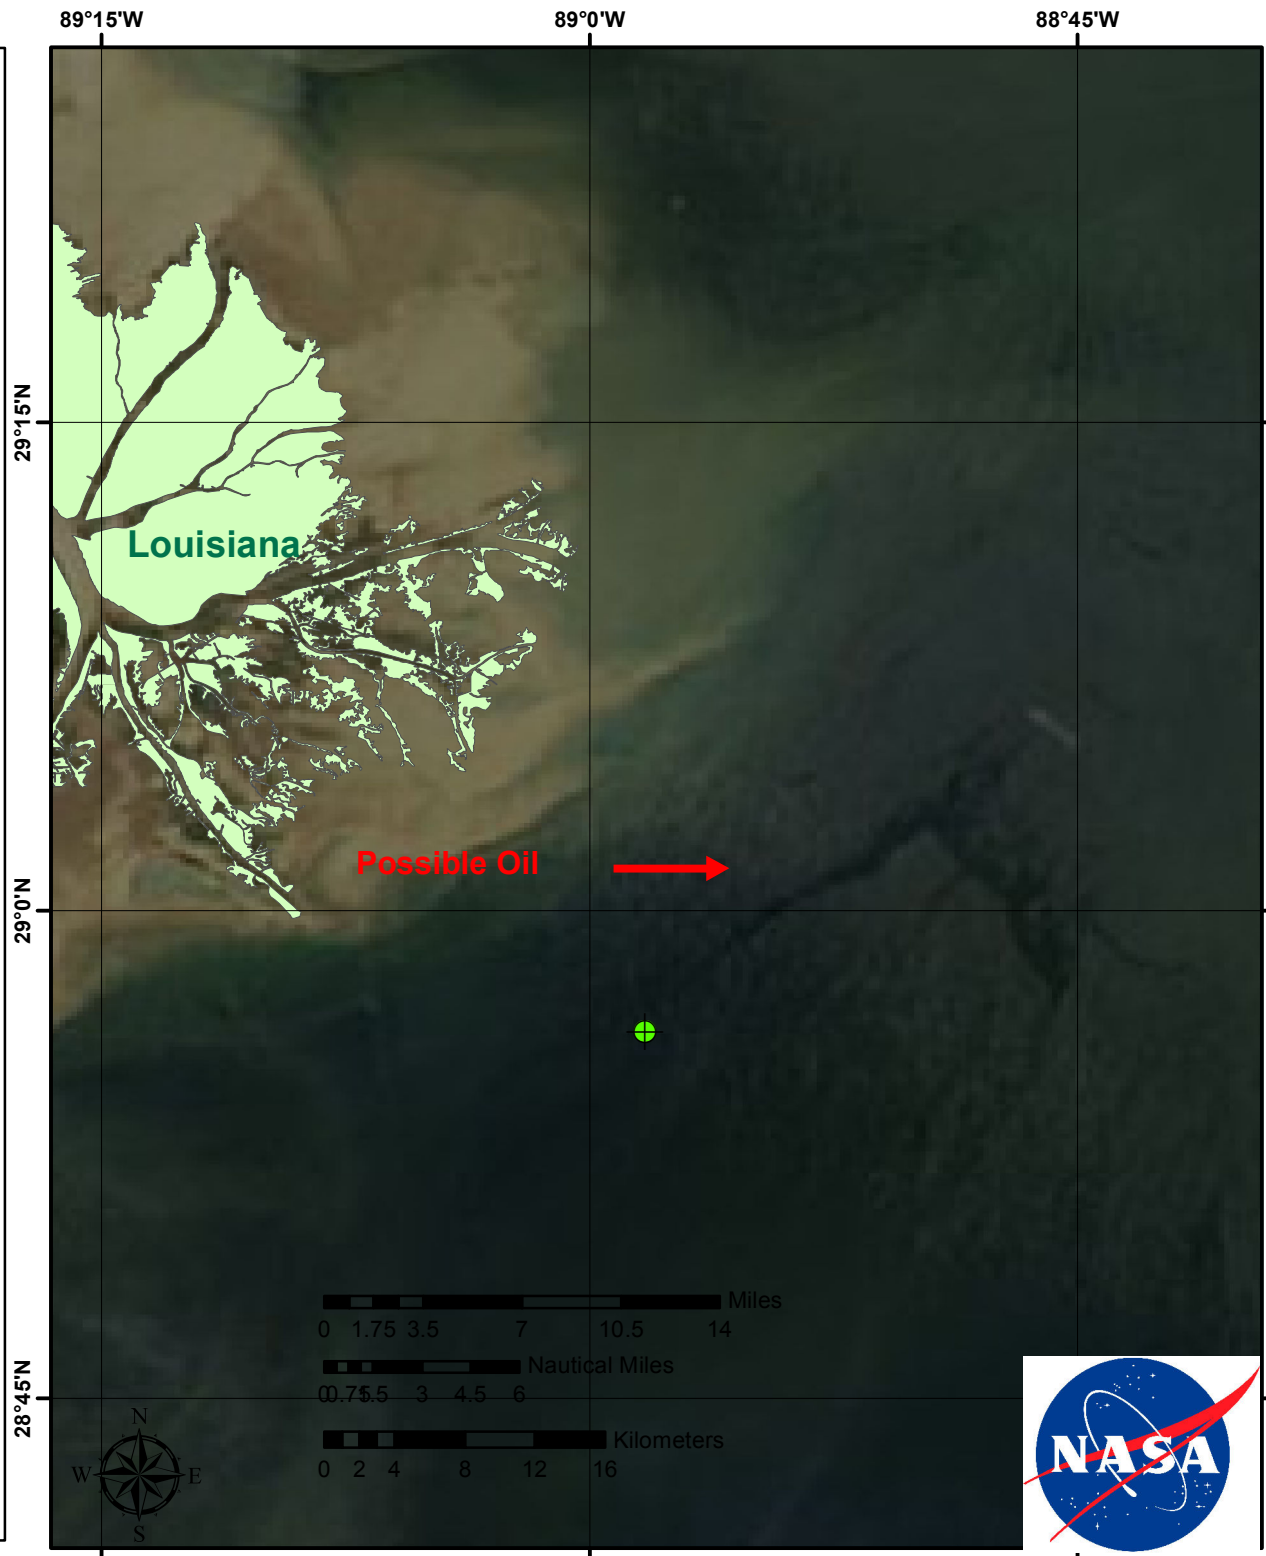
52 km<sup>2</sup>

Area of Possible Oil

A possible oil slick extended to the northeast of the destroyed Taylor platform. The general shape and extended distance to the northeast of the platform is consistent with yesterday's analysis and with current surface winds.

The sky conditions were mostly clear at the time of the image and winds were about 5 knots from the south-southwest.
