# MARINE POLLUTION SURVEILLANCE REPORT

Analysis Provided by: The National Oceanic and  
Atmospheric Administration/National Environmental  
Satellite, Data and Information Service (NOAA/NESDIS)

REPORT DATE: OCTOBER 24, 2013  
REPORT TIME: 2336Z (1836 CDT)  
ANALYST: OEGERLE

DATA SOURCE: LANDSAT-8 OLI  
MODE: Multispectral  
RESOLUTION: 30 meter  
IMAGE DATE/TIME: 10/24/2013 1627Z (1127 CDT)

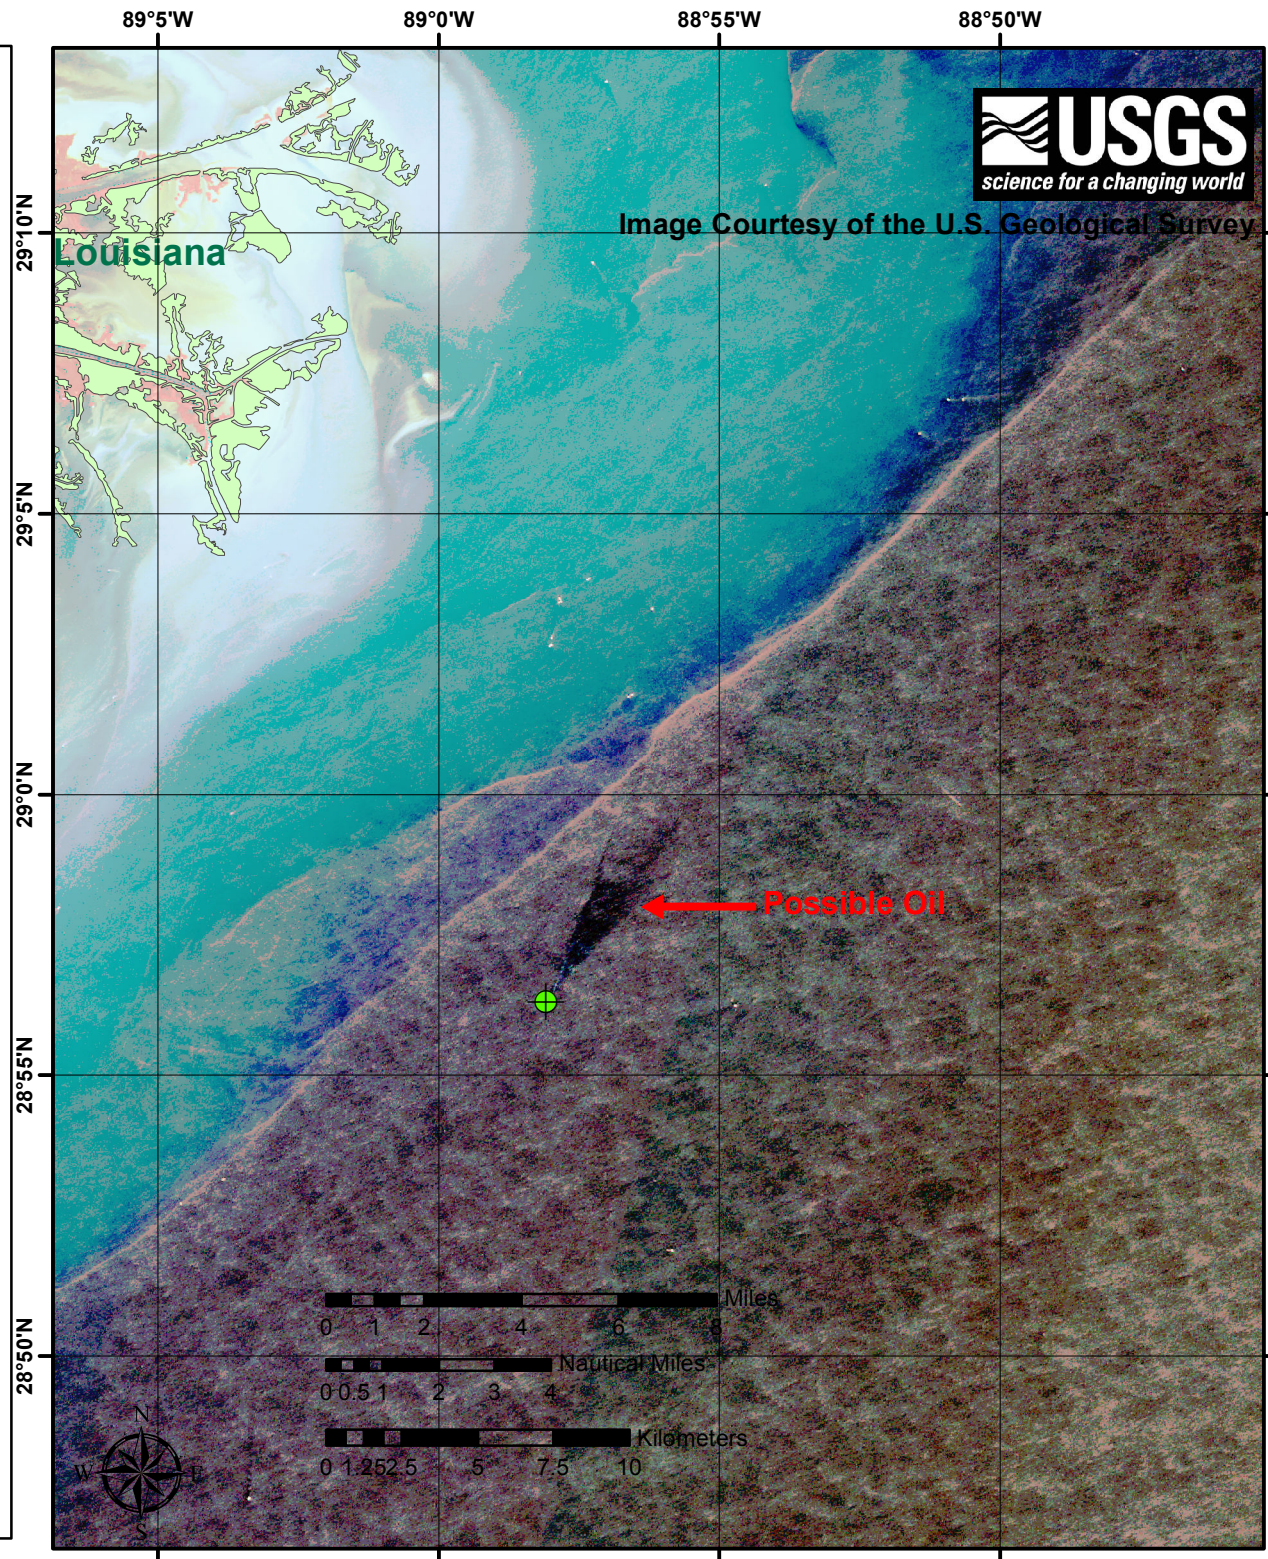
Destroyed Taylor Platform :  
[ 28°56'9" N / 88°58'12" W ]

4.6 km<sup>2</sup> Area of Possible Oil

Suspected oil originating from known repeat leak source near Bird's Foot in the Gulf of Mexico. Possible black slick extends 4.1 miles NE. Low surface winds and ocean currents do not correspond with the orientation of the slick (moving southeast instead of northeast). However, a silver glimmer is visible originating from the point source which is reliable sign of oil in LANDSAT8 imagery out of sunglint. Sky conditions of image time are clear.
