MARINE POLLUTION SURVEILLANCE REPORT

Analysis Provided by: The National Oceanic and
Atmospheric Administration/National Environmental
Satellite, Data and Information Service (NOAA/NESDIS)

REPORT DATE: APRIL 10, 2014
REPORT TIME: 1911Z (1411 CDT)
ANALYST: OEGERLE

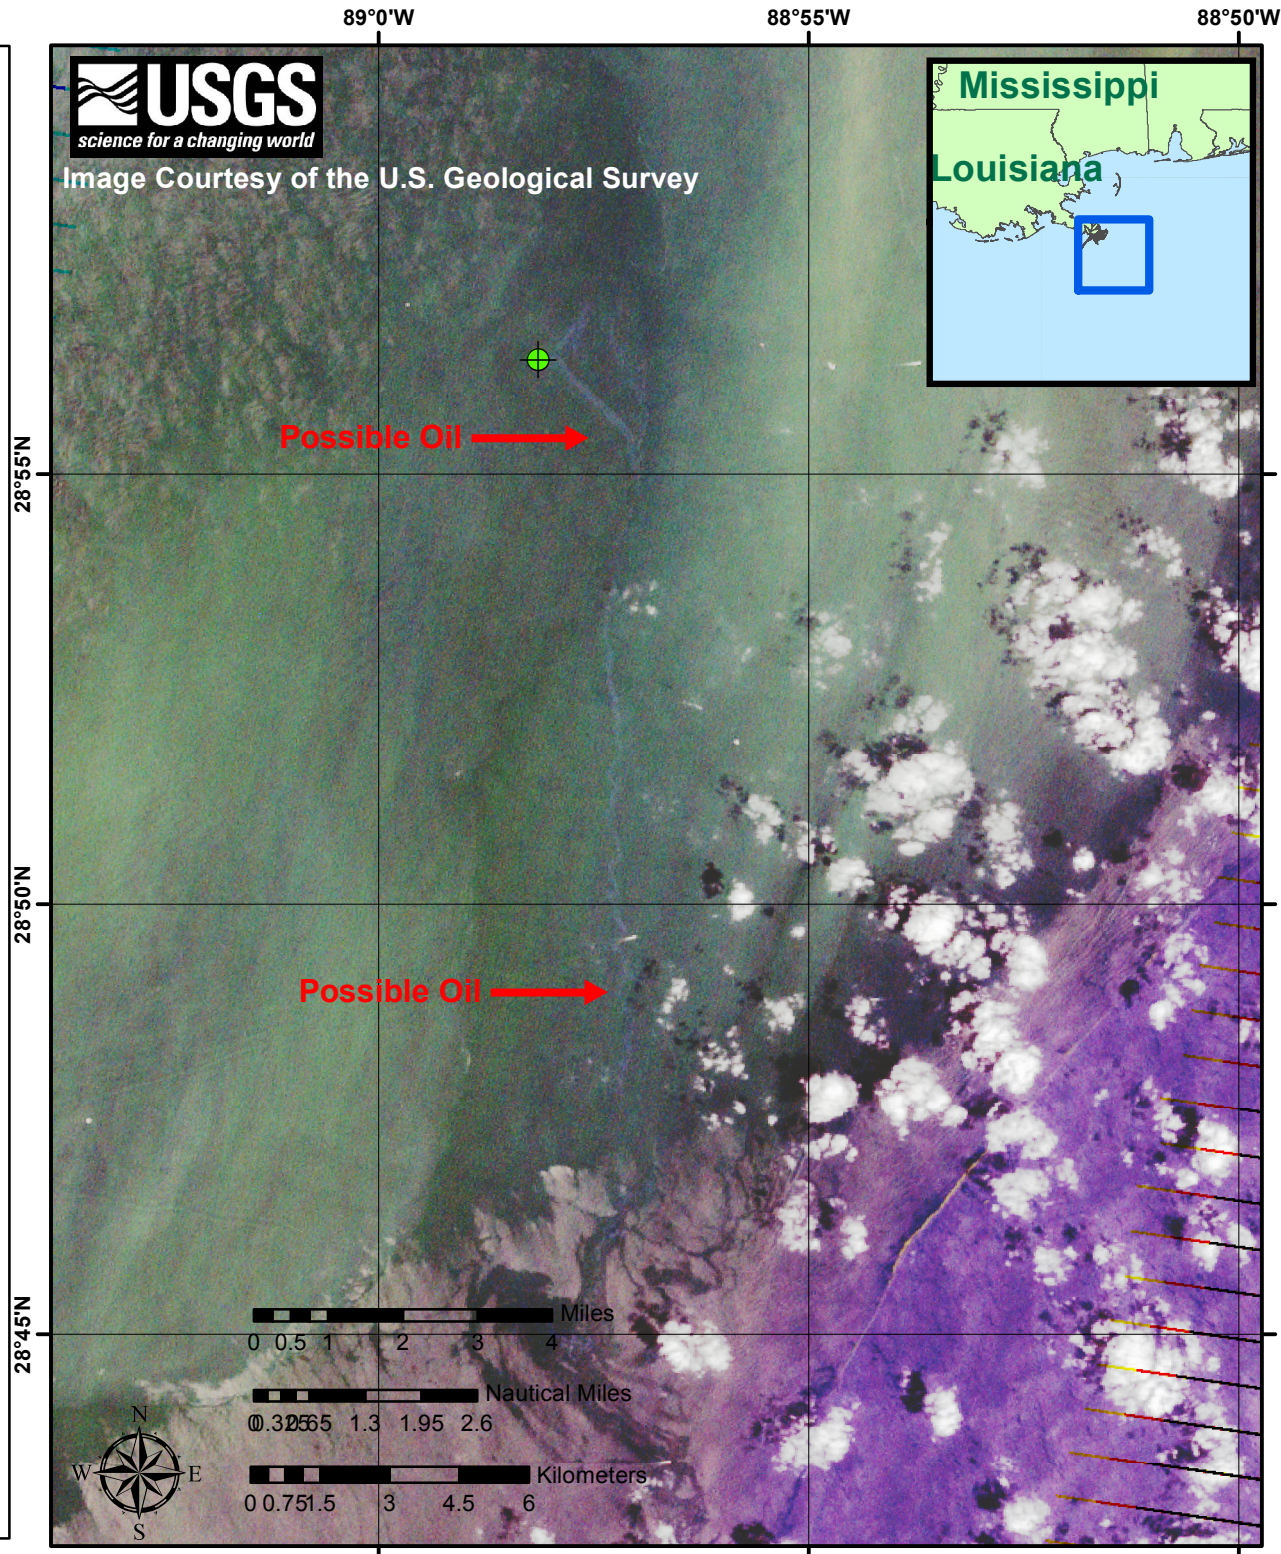
Destroyed Taylor Platform :
[28°56'9" N / 88°58'12" W]

3.02 km² Area of Possible Oil

Suspected oil sheen from a known repeat leak site off of the Bird's Foot of Louisiana. The suspected oil sheen is a total of 10 miles long which is bisected by a moving vessel towards the end. The first segment is 8.2 miles long and the second segment measures 1.8 miles long. NRC report #1079370 confirms a 12 mile sheen from leak site and cites a "bright coloration" that is consistent with the anomaly in satellite imagery. Image time is consistent with favorable winds and cloud conditions of the area, but not ocean current models. Confidence of suspected oil is Medium-High.
