# MARINE POLLUTION SURVEILLANCE REPORT

Analysis Provided by: The National Oceanic and  
Atmospheric Administration/National Environmental  
Satellite, Data and Information Service (NOAA/NESDIS)

REPORT DATE: APRIL 20, 2014

Destroyed Taylor Platform :  
[ 28°56'9" N / 88°58'12" W ]

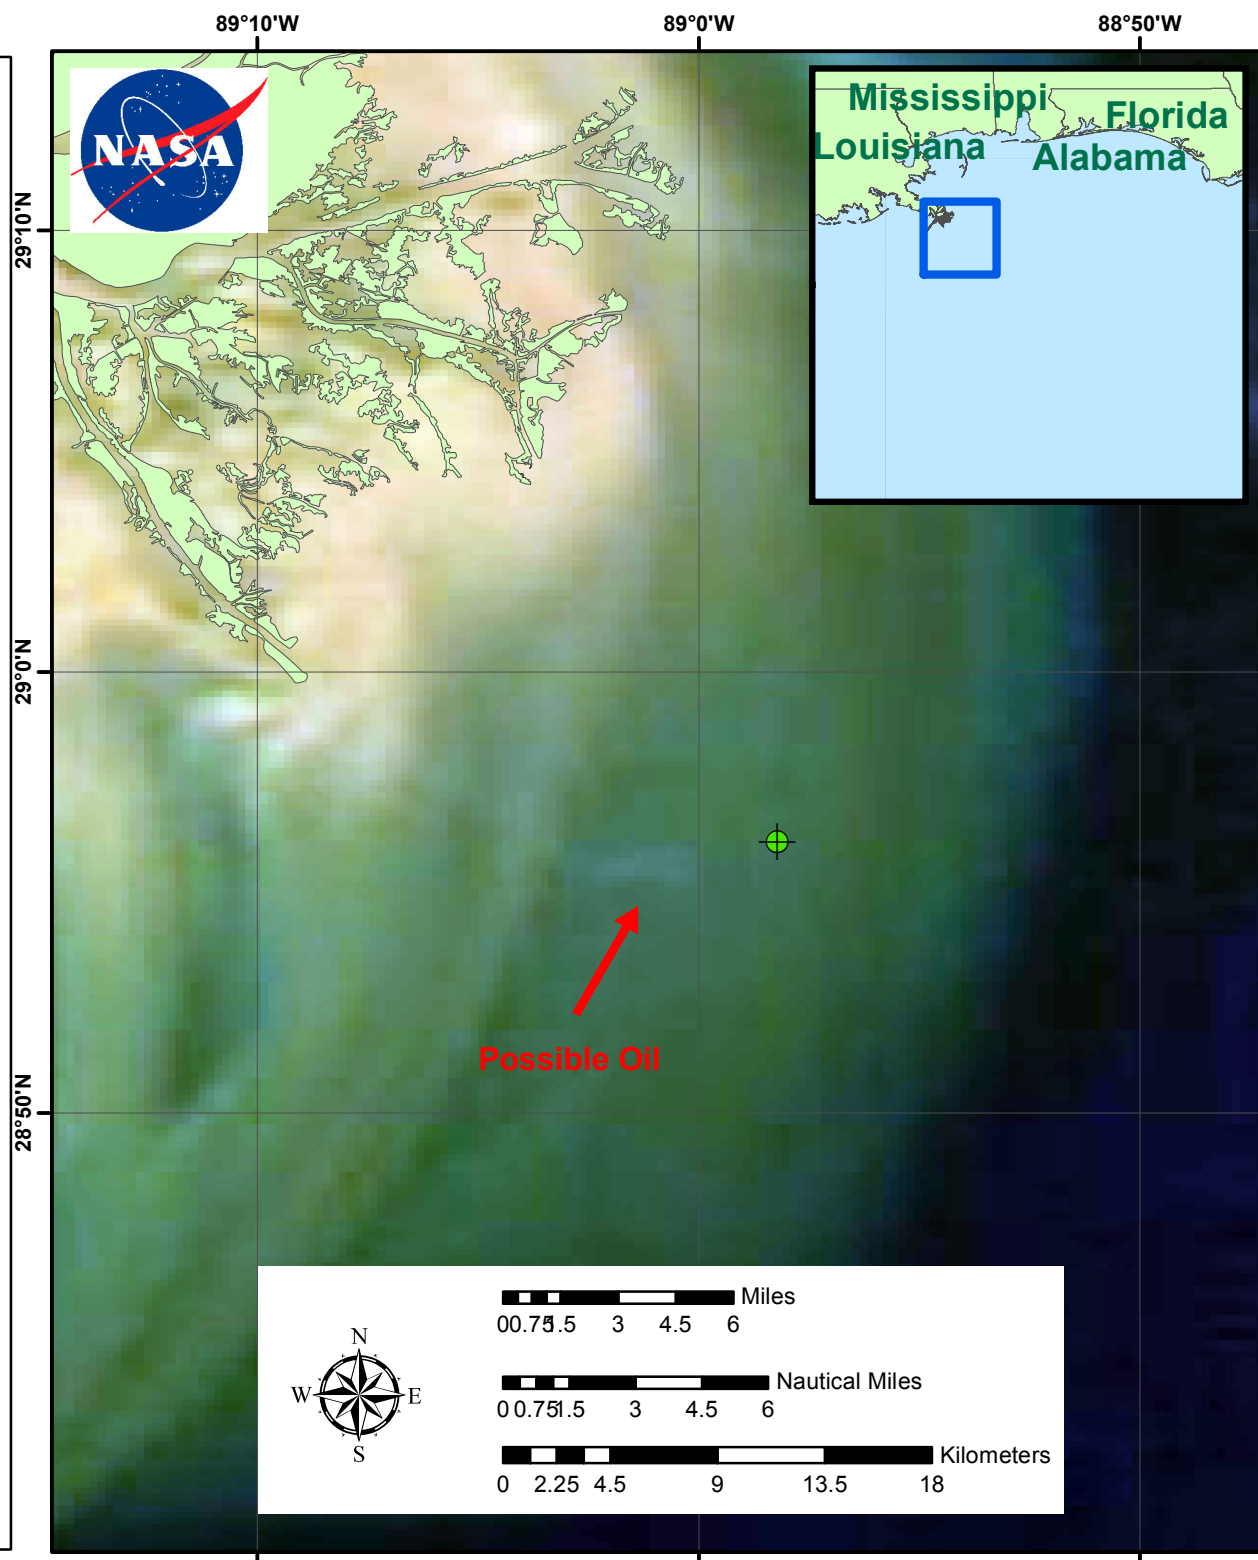
Possible oil extends for approximately 3 miles along a east to west axis and suspected point source is the Destroyed Taylor Platform, a repeat leak source. The anomaly has a bright colorization appearance to it. Ocean currents are out of the east supporting the general orientation of the suspected anomaly. However surface winds are out the north at 5-10 knots increasing uncertainty. Moving sediment is also in the vicinity of the anomaly, also providing some uncertainty.
