# MARINE POLLUTION SURVEILLANCE REPORT

REPORT DATE: APRIL 27, 2014  
REPORT TIME: 2145Z (1645 CDT)  
ANALYST: JANKOT

DATA SOURCE: AQUA MODIS  
MODE: Multispectral  
RESOLUTION: 250 meter  
IMAGE DATE/TIME: 4/27/2014 1855Z (1355 CDT)

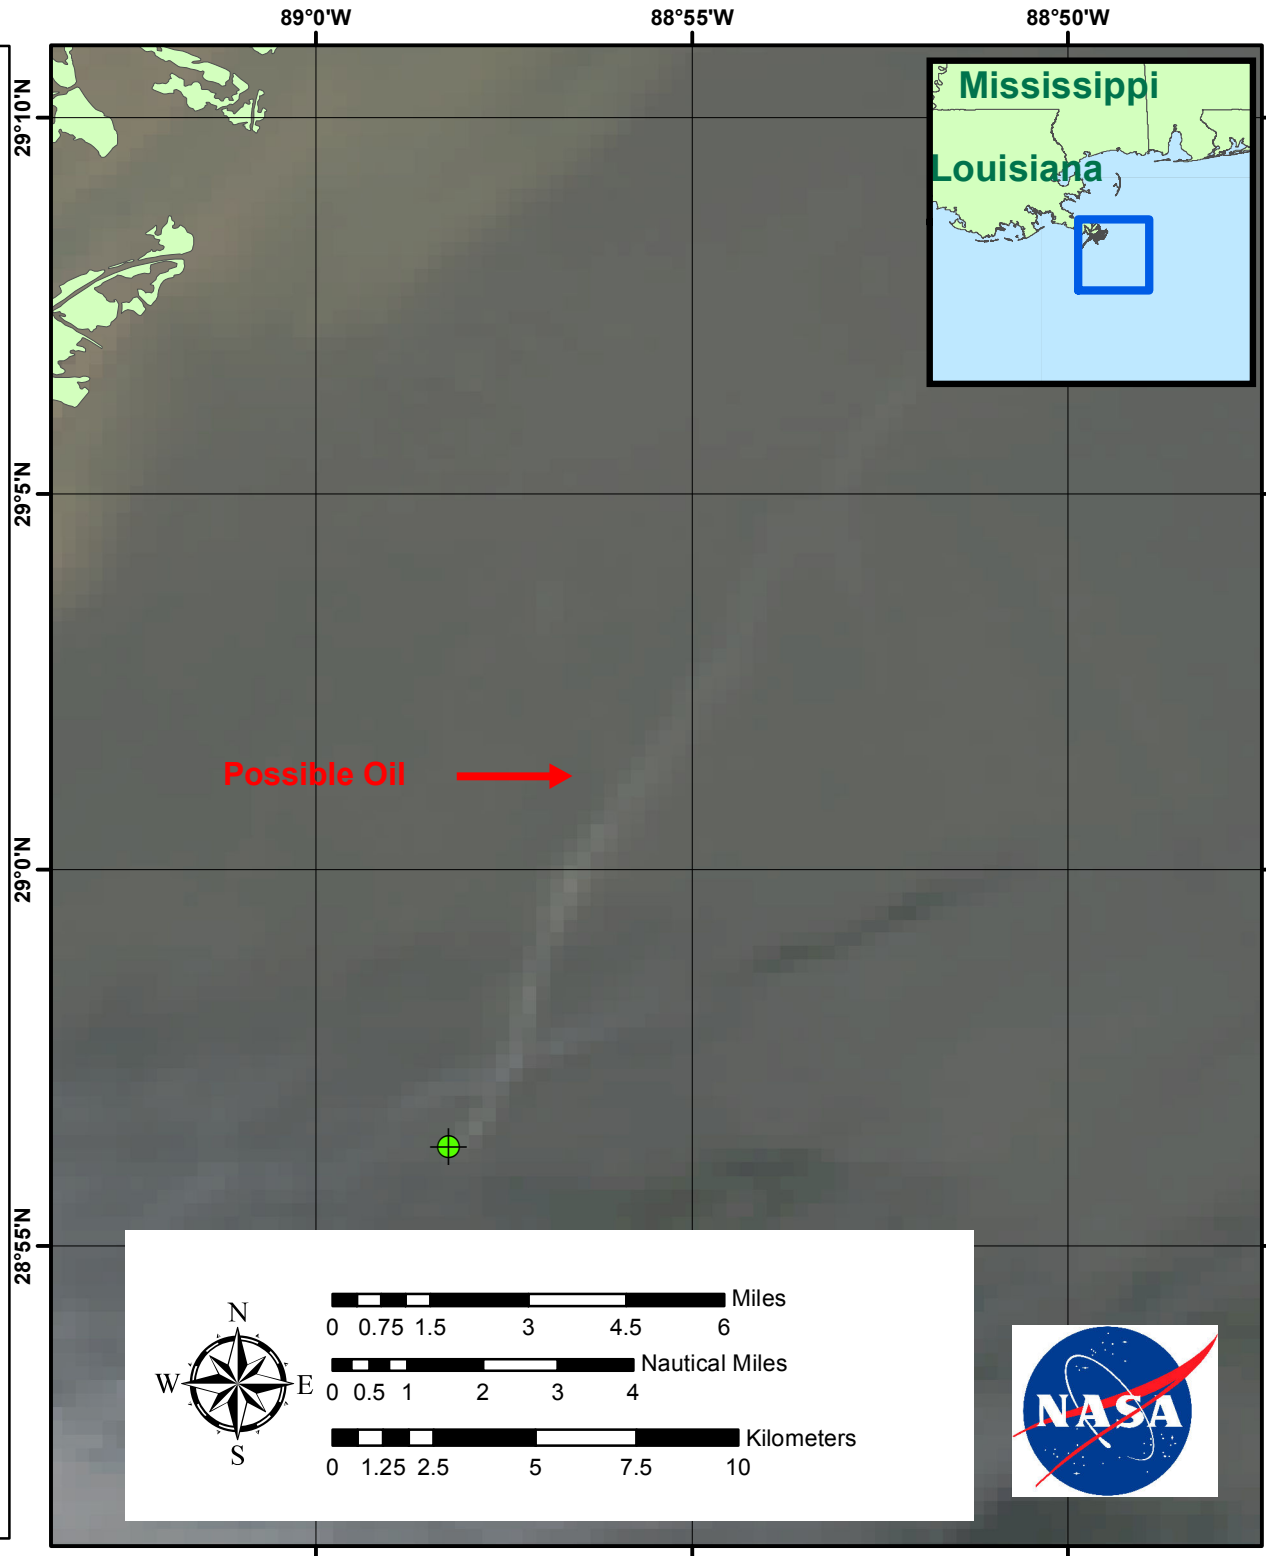
Destroyed Taylor Platform :  
[ 28°56'9" N / 88°58'12" W ]

14.9 km<sup>2</sup> Area of Possible Oil

REMARKS: Suspected slick is from a known repeat leak site off the Birds' Foot of Louisiana. The suspected slick extends for approximately 19 miles long to the north east of the suspected point source and is as wide as .6 miles. The anomaly appears as a "bright colorization" in sun glint. Surface winds are not consistent with the orientation of the slick, out of the southeast at 10 -15 knots. In addition ocean currents were weak at the time of the image.
