# MARINE POLLUTION SURVEILLANCE REPORT

Analysis Provided by: The National Oceanic and  
Atmospheric Administration/National Environmental  
Satellite, Data and Information Service (NOAA/NESDIS)

REPORT DATE: AUGUST 08, 2014

DATA SOURCE: AQUA MODIS

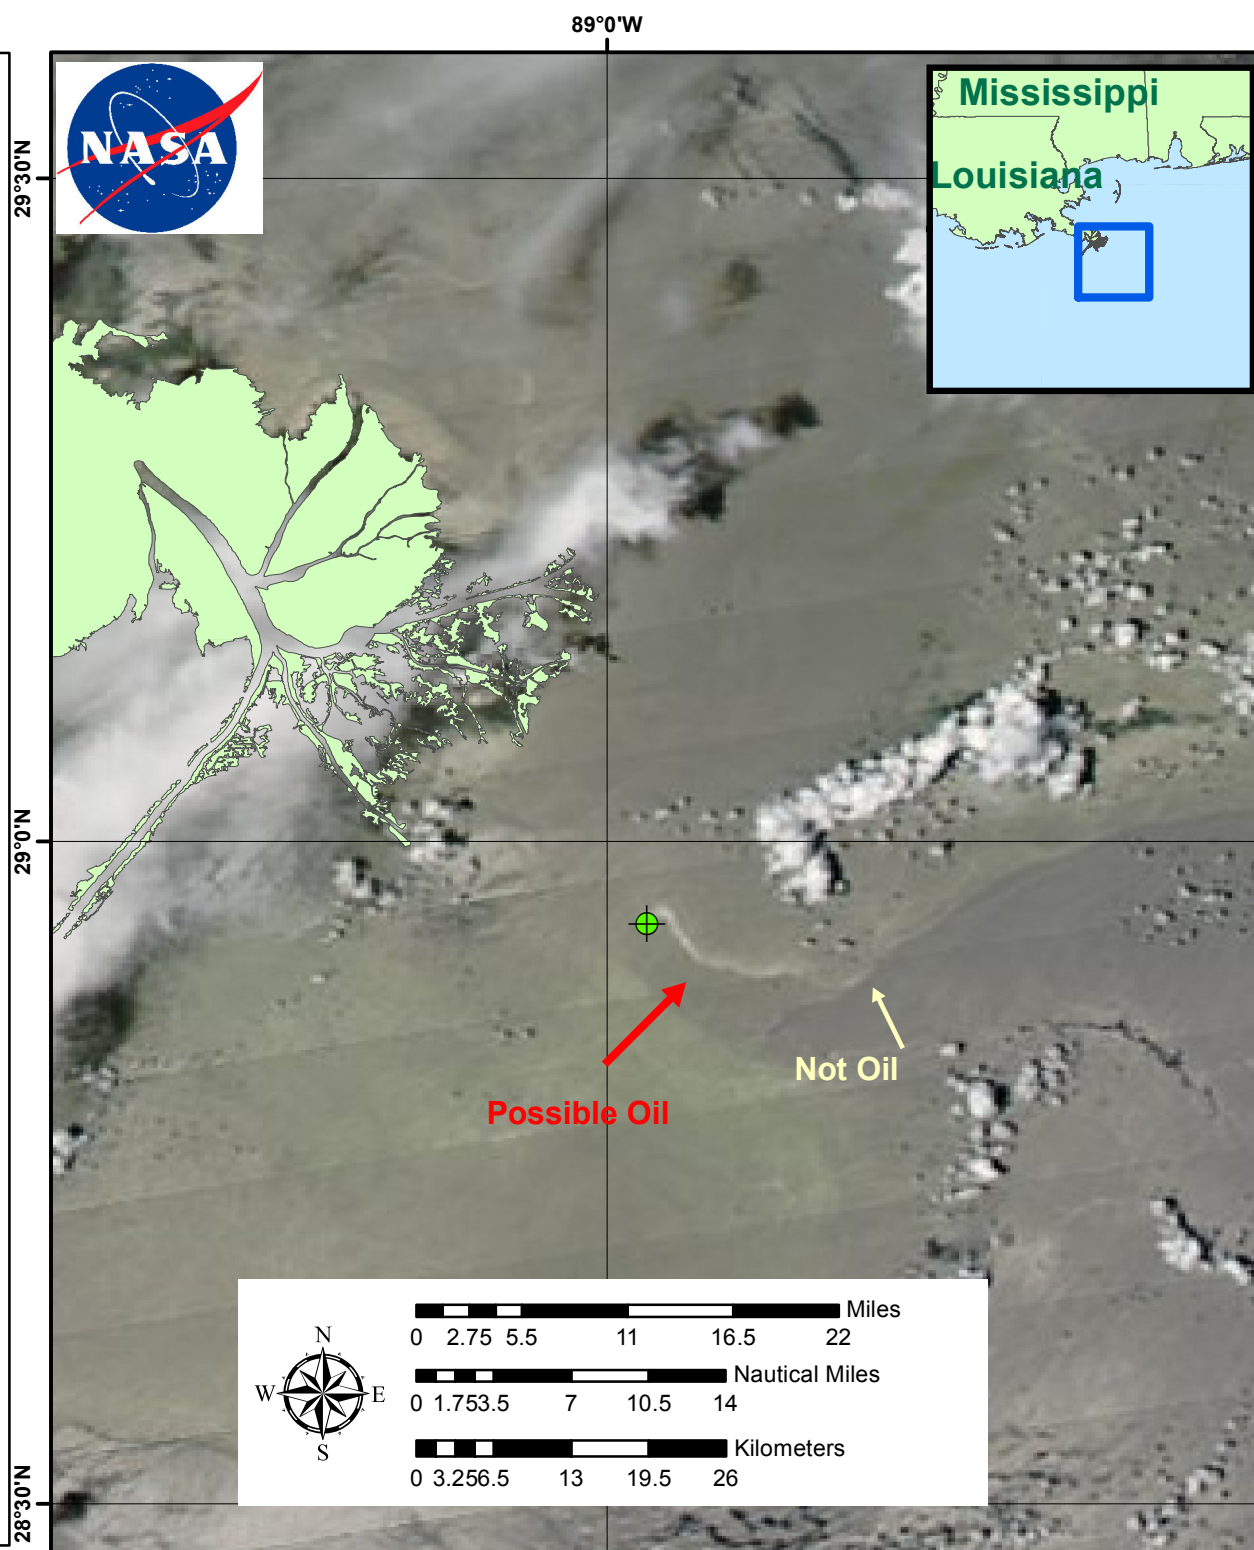
Destroyed Taylor Platform :  
[ 28°56'9" N / 88°58'12" W ]

21 km<sup>2</sup> Area of Possible Oil

REMARKS: An area of possible oil extends 15km south and east of the destroyed Taylor platform location. With the white appearance against the dark background and given this is a known repeat leak source, confidence is high the anomaly is oil. The oil extends toward another feature which has a darker appearance and may be due to bathymetry.
