MARINE POLLUTION SURVEILLANCE REPORT

Analysis Provided by: The National Oceanic and
Atmospheric Administration/National Environmental
Satellite, Data and Information Service (NOAA/NESDIS)

REPORT DATE: AUGUST 23, 2014
REPORT TIME: 1835Z (1335 CDT)
ANALYST: OEGERLE

DATA SOURCE: TERRA MODIS
MODE: Multispectral
RESOLUTION: 250 meter
IMAGE DATE/TIME: 8/23/2014 1650Z (1150 CDT)

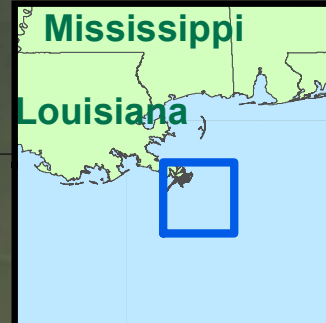
Destroyed Taylor Platform :
[28°56'9" N / 88°58'12" W]

17.2 km² Area of Possible Oil

Suspected oil originating from known repeat leak source located off the coast of the Bird's Foot in Louisiana in the Gulf of Mexico. Oil appears silver in color in the satellite image because it is located in sunglint. Slick extends 12.3 miles long and 1 mile wide in length. Sky conditions in the immediate area are clear, however a large cloud obscures the length (the slick may extend further east.) The wind speed and direction is agreeable with slick orientation. Confidence of oil is high.
