# MARINE POLLUTION SURVEILLANCE REPORT

Analysis Provided by: The National Oceanic and  
Atmospheric Administration/National Environmental  
Satellite, Data and Information Service (NOAA/NESDIS)

REPORT DATE: AUGUST 24, 2014  
REPORT TIME: 2302Z (1802 CDT)  
ANALYST: OEGERLE

Destroyed Taylor Platform :  
[ 28°56'9" N / 88°58'12" W ]

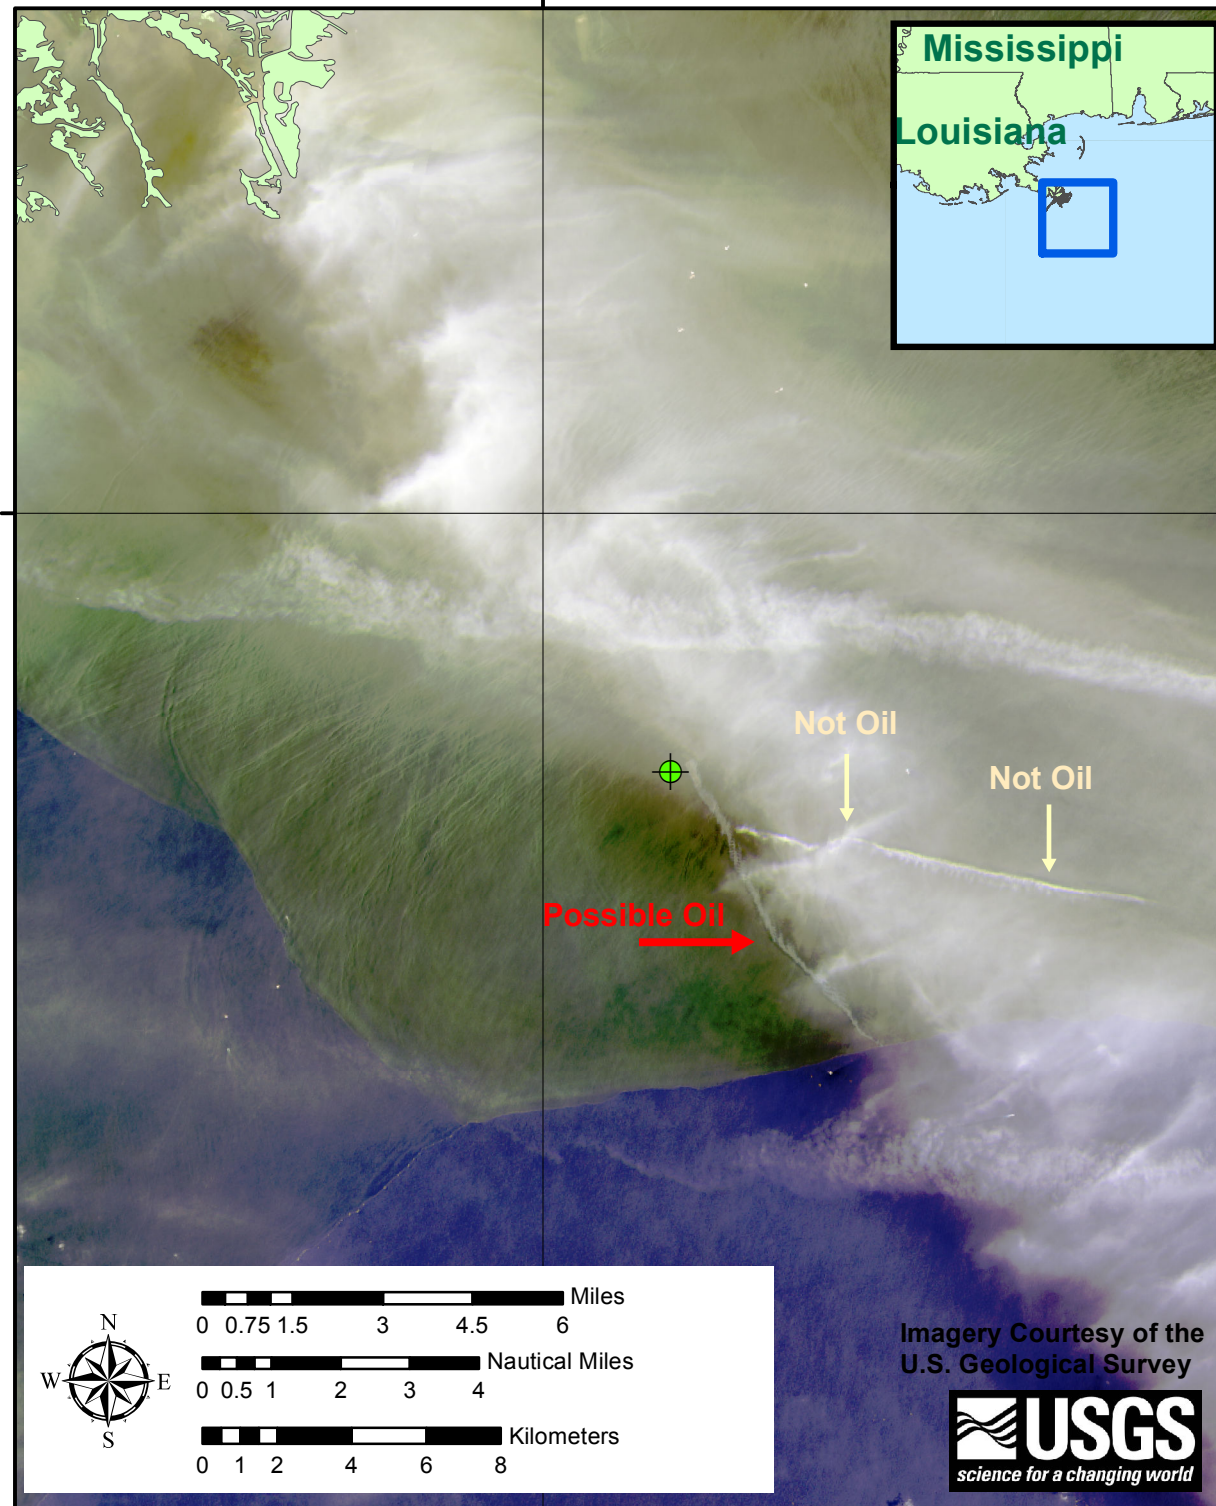
3.9 km<sup>2</sup> Area of Possible Oil

Suspected oil originating from known repeat leak source located off the Gulf of Mexico. Oil appears silver in color in satellite image because it is located in sunglint. Slick extends 5.5 miles long and 0.5 mile wide in length. Sky conditions partially obscure the view due to clouds in the immediate area, as well as a white aircraft contrail located to the east of the anomaly. The wind speed and direction is agreeable with slick orientation. Confidence of oil is high.
