MARINE POLLUTION SURVEILLANCE REPORT

Analysis Provided by: The National Oceanic and
Atmospheric Administration/National Environmental
Satellite, Data and Information Service (NOAA/NESDIS)

REPORT DATE: JULY 06, 2014
REPORT TIME: 1920Z (1420 CDT)
ANALYST: GALLINA

DATA SOURCE: TERRA MODIS
MODE: Multispectral
RESOLUTION: 250 meter
IMAGE DATE/TIME: 7/6/2014 1630Z (1130 CDT)

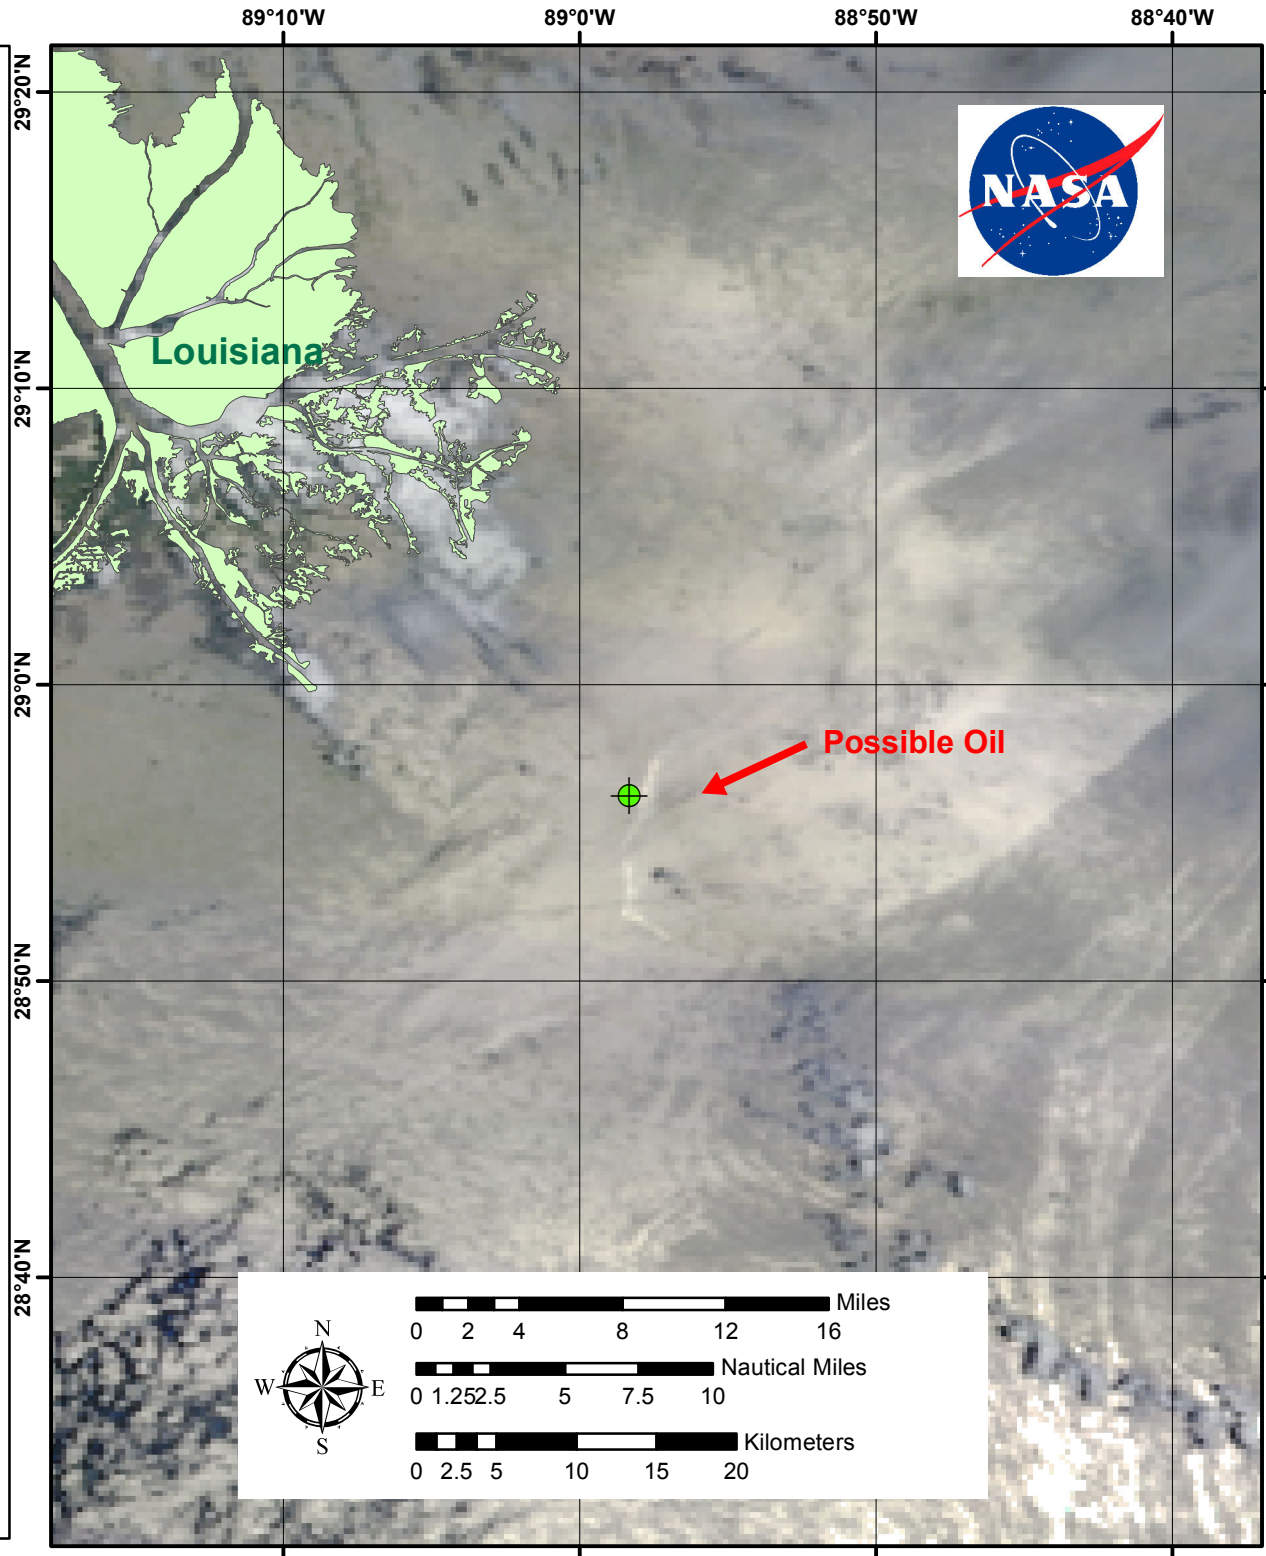
Destroyed Taylor Platform :
[28°56'9" N / 88°58'12" W]

10.2 km² Area of Possible Oil

REMARKS: 7 mile long (north to south) and .7 mile wide
slick which appears bright and slivery within sun glint
area at known leak site (Destroyed Taylor) under ideal
sky conditions with light winds for detection.
