# MARINE POLLUTION SURVEILLANCE REPORT

Analysis Provided by: The National Oceanic and  
Atmospheric Administration/National Environmental  
Satellite, Data and Information Service (NOAA/NESDIS)

REPORT DATE: JULY 24, 2014

IMAGE DATE/TIME: 7/23/2014 1905Z (1405 CDT)

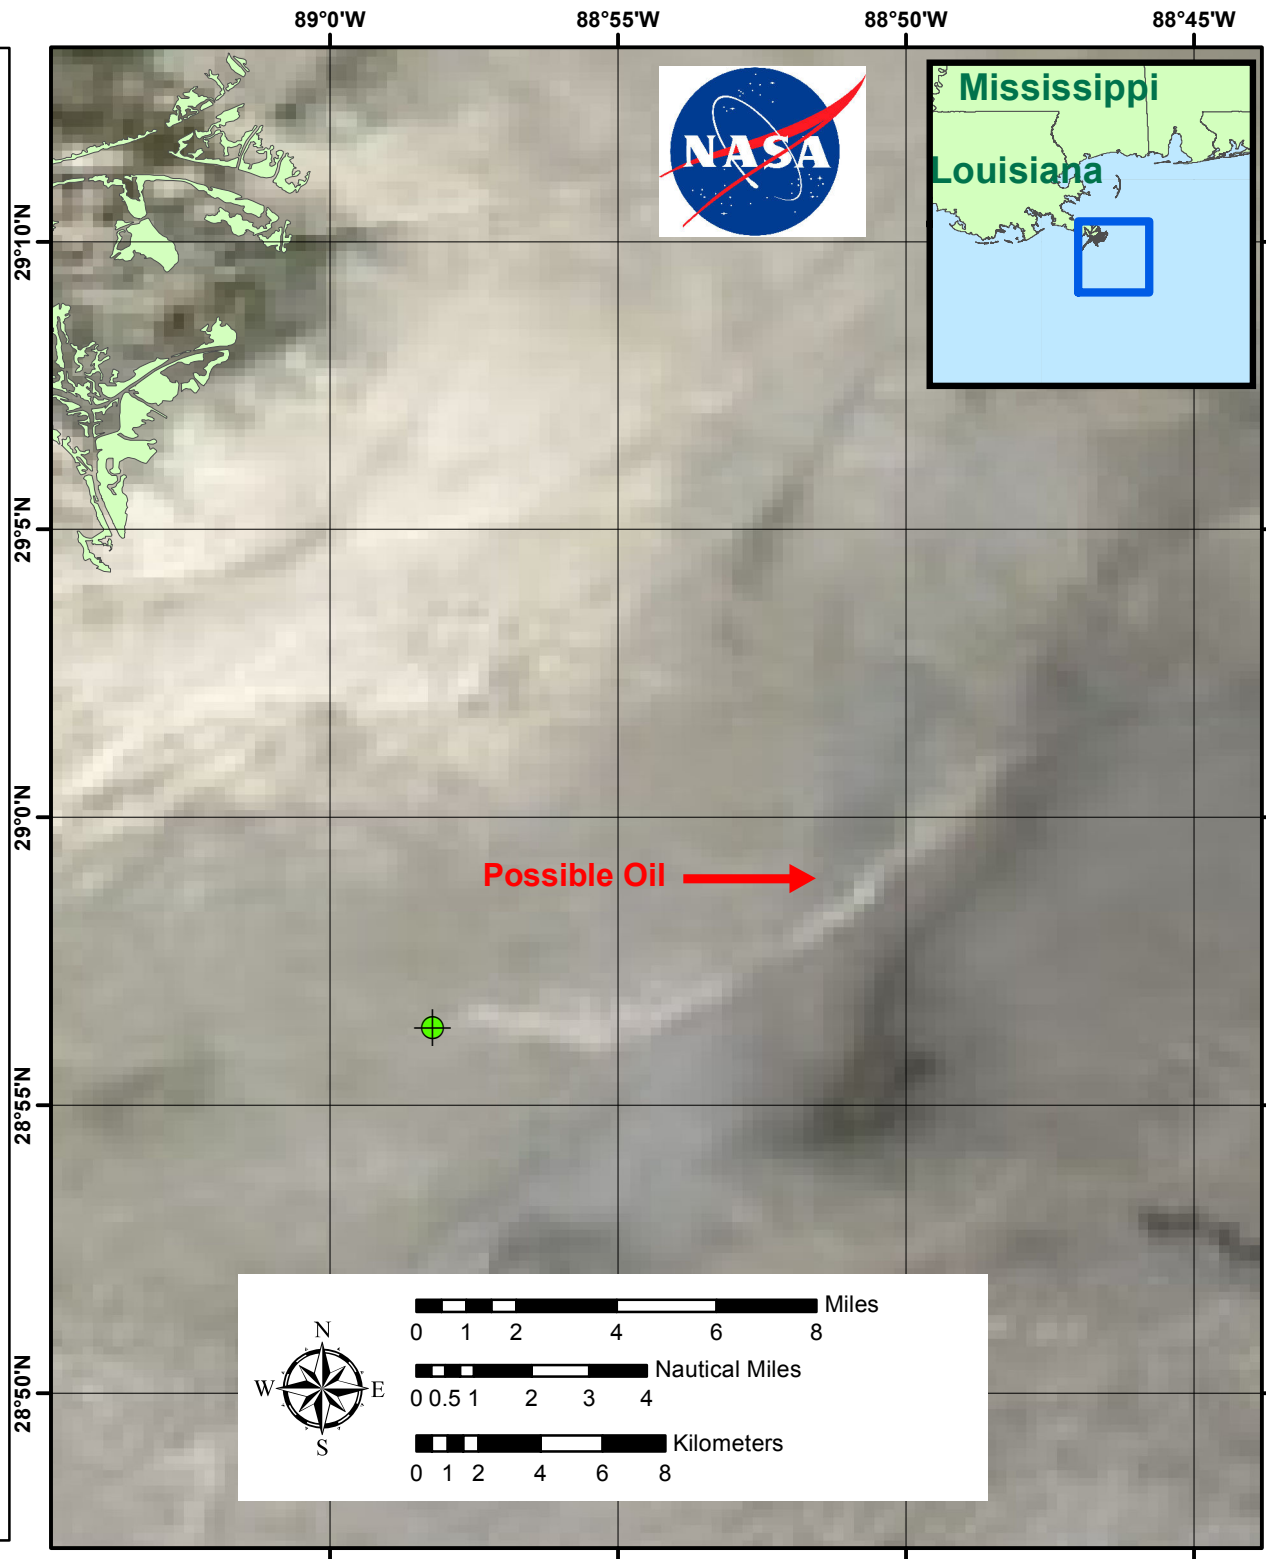
Destroyed Taylor Platform :  
[ 28°56'9" N / 88°58'12" W ]

17.1 km<sup>2</sup> Area of Possible Oil

Possible oil is connected to the Destroyed Taylor Platform, a repeat leak source. The slick extends for approximately 12 miles to the east-northeast of the suspected point source.

Sky conditions were partly cloudy and winds were from the southwest at 10 knots at the time of the image.
