# MARINE POLLUTION SURVEILLANCE REPORT

REPORT DATE: JUNE 06, 2014  
REPORT TIME: 1140Z (0640 CDT)  
ANALYST: VOGT MILLER

DATA SOURCE: LANDSAT-8 OLI  
MODE: Multispectral  
RESOLUTION: 30 meter  
IMAGE DATE/TIME: 6/5/2014 1625Z (1125 CDT)

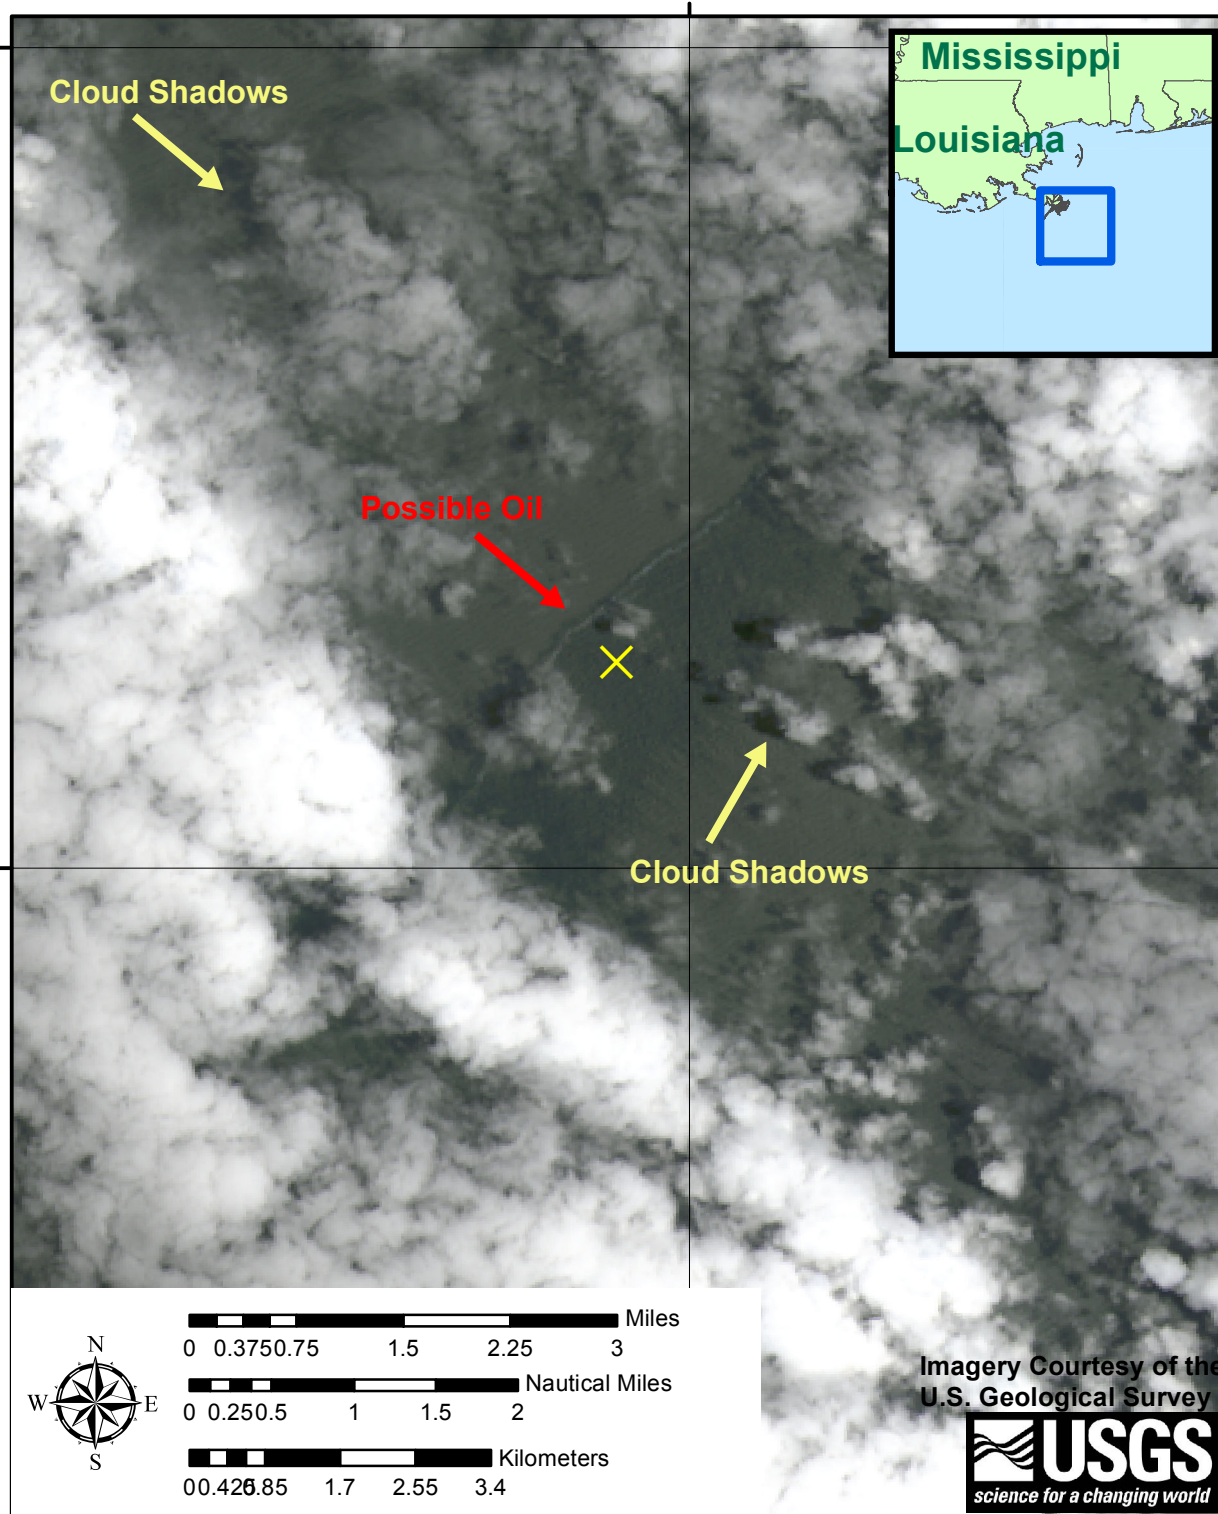
Center Point of Oil Slick:  
[ 28°51'16" N / 89°00'21" W ]
-

5.7 km<sup>2</sup> Area of Possible Oil

An area of possible oil is located about 4.6 miles southwest of the Destroyed Taylor Platform in the Gulf of Mexico. The oil has a silvery sheen on the northern edge and then feathers out to the southeast. The portion of the slick that is visible in the image is about 1 mile wide by 2.9 miles long. Due to the cloud coverage, the oil could not be traced back to any confirmed point source. Surface winds around the time of the image were fairly weak and directed to the southwest.
