MARINE POLLUTION SURVEILLANCE REPORT

Analysis Provided by: The National Oceanic and
Atmospheric Administration/National Environmental
Satellite, Data and Information Service (NOAA/NESDIS)

REPORT DATE: MAY 04, 2014
REPORT TIME: 2155Z (1655 CDT)
ANALYST: JANKOT

DATA SOURCE: AQUA MODIS
MODE: Multispectral
RESOLUTION: 250 meter
IMAGE DATE/TIME: 5/4/2014 1900Z (1400 CDT)

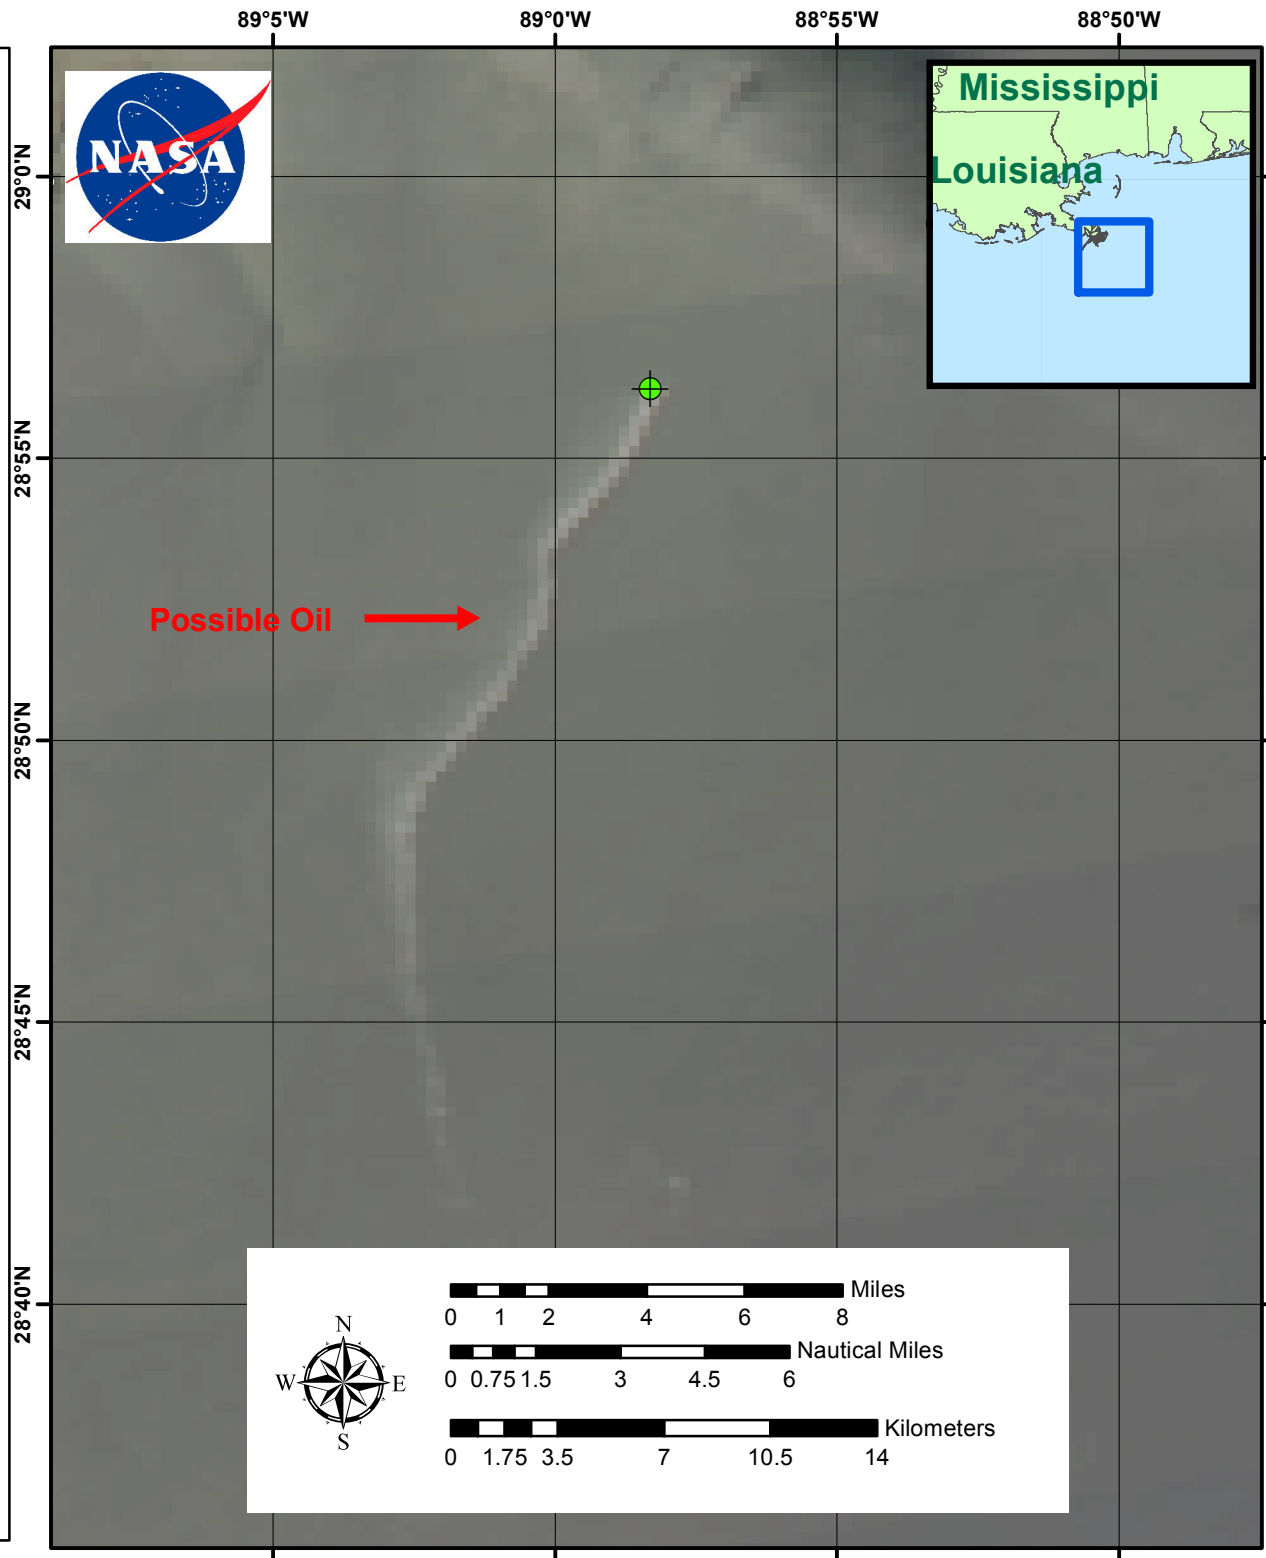
Destroyed Taylor Platform :
[28°56'9" N / 88°58'12" W]

24.5 km² Area of Possible Oil

Suspected oil slick originating from the Destroyed Taylor Platform, a repeat leak source. The anomaly measured 18 miles long and as wide as .9 miles. Ocean currents agree with the orientation of the slick with modeled currents out of the north-northeast. However surface winds were 5-10 knots out of the west north-west. High confidence in this anomaly as this was also seen in yesterday's Terra pass in addition to a silver appearance in sunglint.
