MARINE POLLUTION SURVEILLANCE REPORT

Analysis Provided by: The National Oceanic and
Atmospheric Administration/National Environmental
Satellite, Data and Information Service (NOAA/NESDIS)

REPORT DATE: OCTOBER 12, 2014
REPORT TIME: 0115Z (10/11/2014 2015 CDT)
ANALYST: VELASCO

DATA SOURCE: LANDSAT-8 OLI
MODE: Multispectral
RESOLUTION: 30 meter
IMAGE DATE/TIME: 10/11/2014 1626Z (1126 CDT)

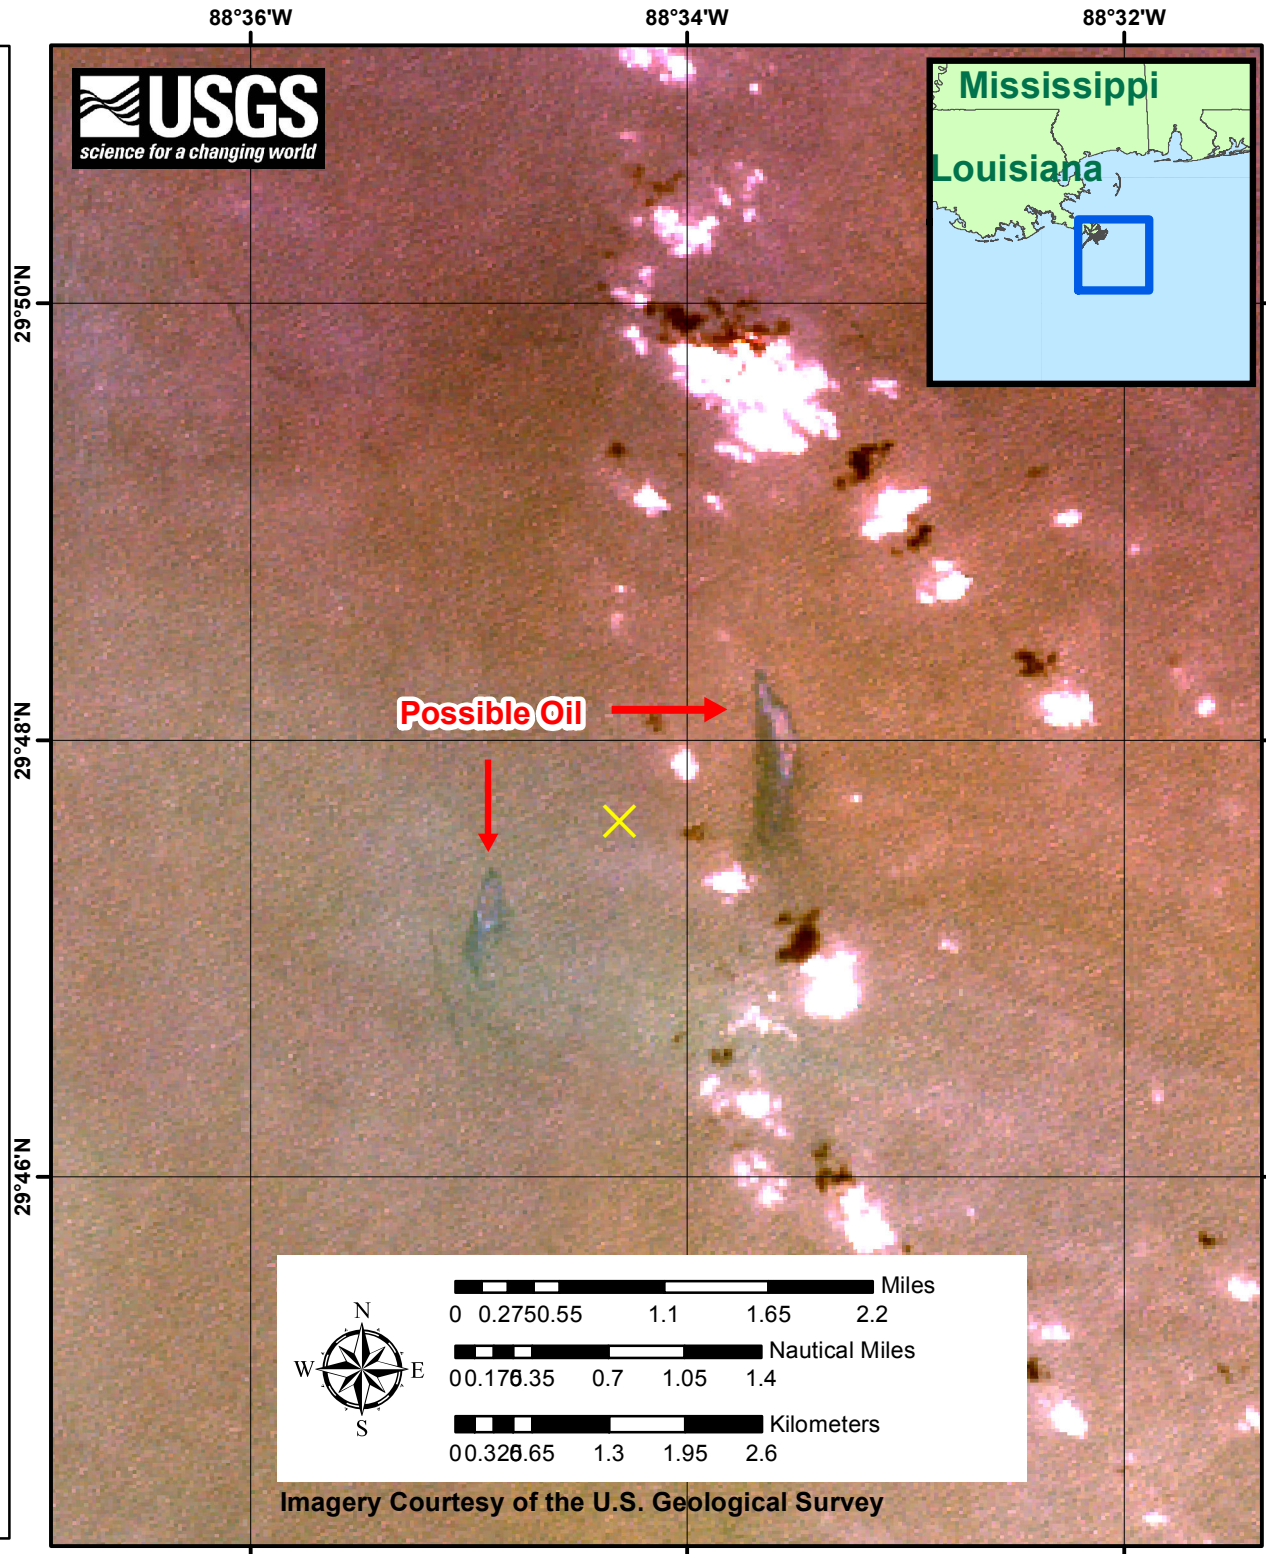
Center Point of Oil Slick:
[29°47'36" N / 88°34'13" W]
-

Area of Possible Oil

Confidence: Medium

Two silver and black anomalies believed to be oil
slick were detected 16 miles west of the
Chandeleur Islands. The irregularly-shaped
anomalies span across an area 2.1 miles long and
1 mile wide. Their orientation is supported by the
northward current at the time the image was taken.
There is no known point source, however, the area
contains many oil platforms.
