MARINE POLLUTION SURVEILLANCE REPORT

Analysis Provided by: The National Oceanic and
Atmospheric Administration/National Environmental
Satellite, Data and Information Service (NOAA/NESDIS)

REPORT DATE: SEPTEMBER 01, 2014
REPORT TIME: 1946Z (1446 CDT)
ANALYST: VELASCO

DATA SOURCE: LANDSAT-7 ETM+
MODE: Multispectral
RESOLUTION: 30 meter
IMAGE DATE/TIME: 9/1/2014 1623Z (1123 CDT)

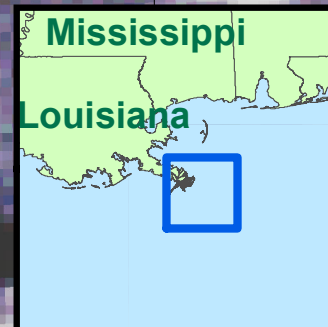
Area of Possible Oil

Confidence: Medium-High

Possible oil slick located 14.7 miles southwest of the the Bird's Foot Delta and suspected to be originating from the destroyed Taylor platform. The slick is 0.9 miles long and 0.2 miles wide, and its east-west orientation may be due to the southeasterly winds and currents going in a southeast direction. The sky conditions in the area were partly cloudy.
