MARINE POLLUTION SURVEILLANCE REPORT

Analysis Provided by: The National Oceanic and
Atmospheric Administration/National Environmental
Satellite, Data and Information Service (NOAA/NESDIS)

REPORT DATE: SEPTEMBER 17, 2014
REPORT TIME: 2145Z (1645 CDT)
ANALYST: VELASCO

DATA SOURCE: LANDSAT-7 ETM+
MODE: Multispectral
RESOLUTION: 30 meter
IMAGE DATE/TIME: 9/17/2014 1624Z (1124 CDT)

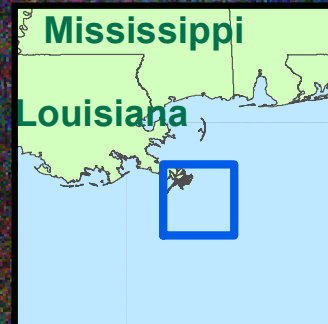
12.2 km² Area of Possible Oil

Confidence: High

Possible oil slick located approximately 13 miles southeast of the Bird's Foot Delta and suspected to be originating from the destroyed Taylor platform. The slick is 4.7 miles long and 2.9 miles wide, and its orientation is supported by the direction of the currents and winds in the area. The full extent of the slick is unknown due to the presence of clouds. The slick tested negative for vegetation.
