REPORT DATE: SEPTEMBER 24, 2014  
REPORT TIME: 0445Z (9/23/2014 2345 CDT)  
ANALYST: JANKOT

Destroyed Taylor Platform :  
 [ 28°56'9" N / 88°58'12" W ]

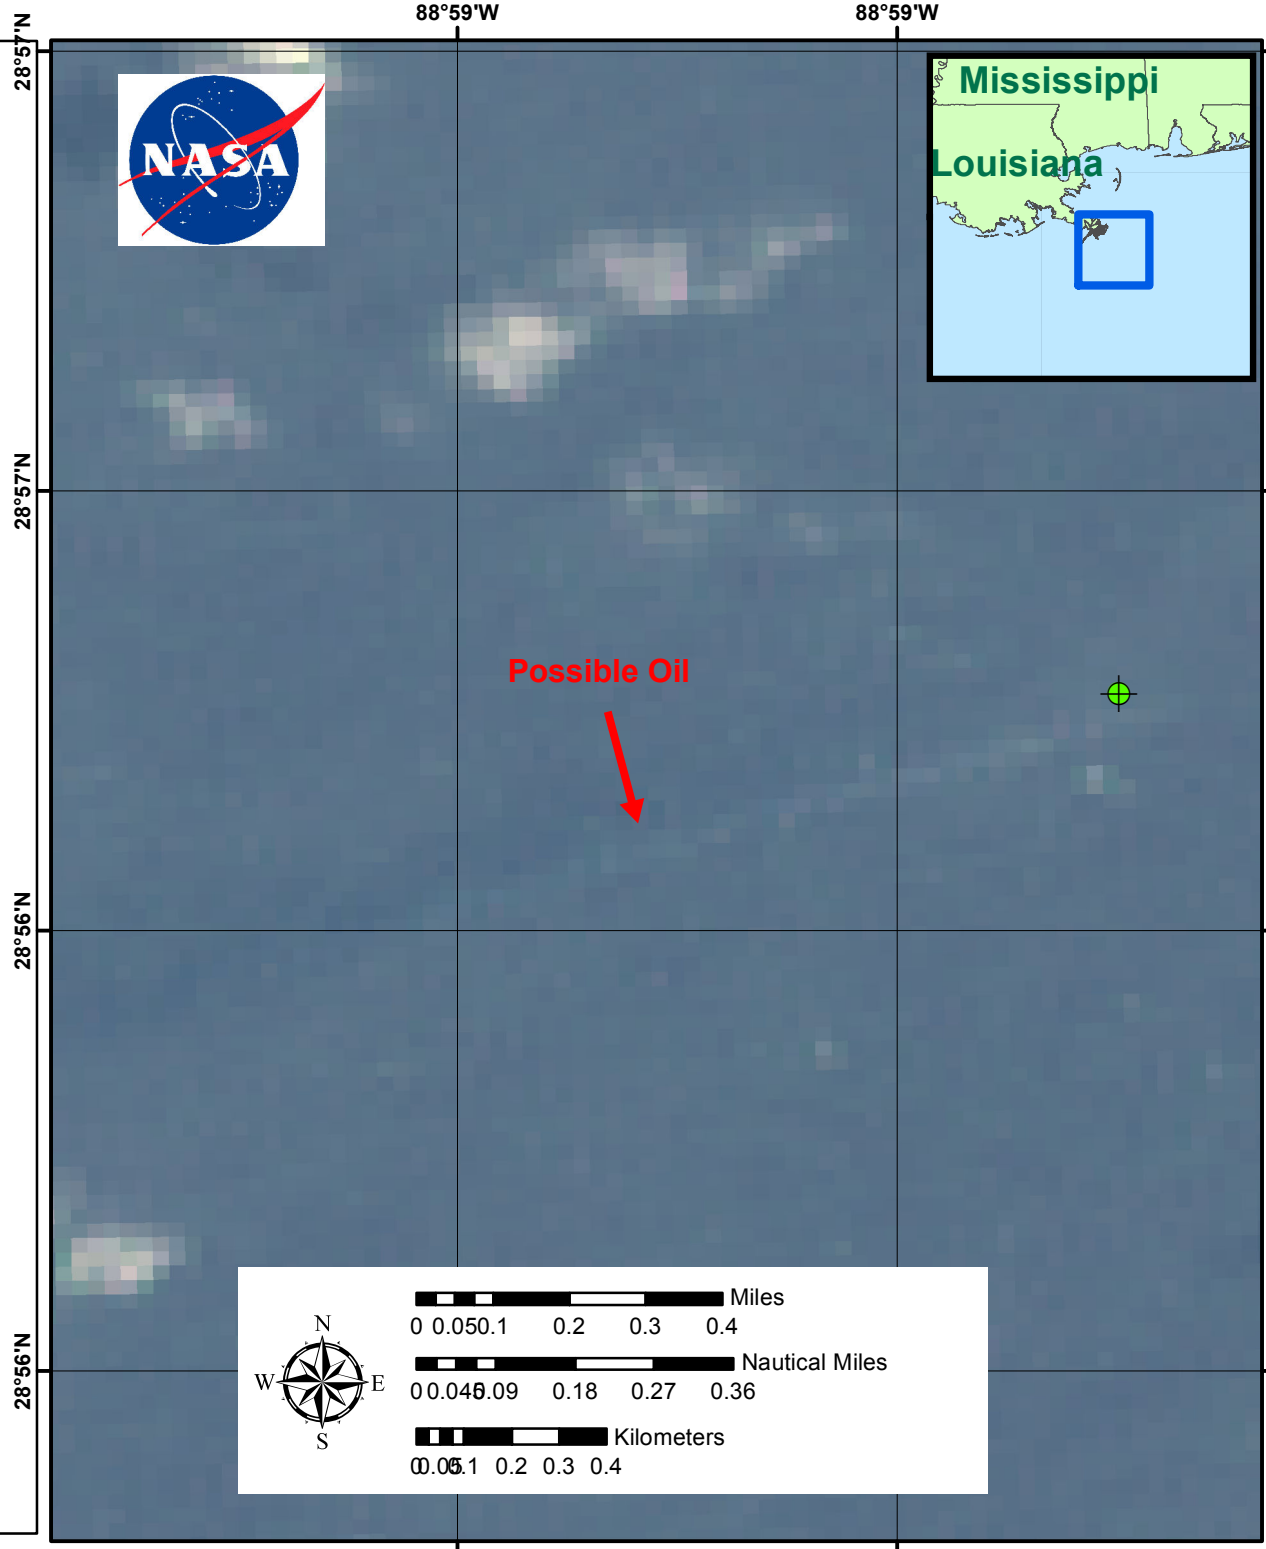
.08 km<sup>2</sup>

**Confidence:** High

Suspected oil is connected to the Destroyed Taylor Platform, a repeat leak source. Oil appears lighter in color and extends for approximately .8 miles to the west-southwest of the suspected point source. Sky conditions were partly cloudy at the time of the image and did not obscure the view of the anomaly. Modeled ocean currents were out of the northeast at time of the image and surface winds also agreed with the orientation of the slick out of the east-northeast at 10-15 knots.
