MARINE POLLUTION SURVEILLANCE REPORT

REPORT DATE: AUGUST 01, 2015
REPORT TIME: 1931Z (1431 CDT)
ANALYST: RAMIREZ

DATA SOURCE: TERRA MODIS
MODE: Multispectral
RESOLUTION: 250 meter
IMAGE DATE/TIME: 8/1/2015 1650Z (1150 CDT)

Destroyed Taylor Platform :
[28°56'9" N / 88°58'12" W]
-

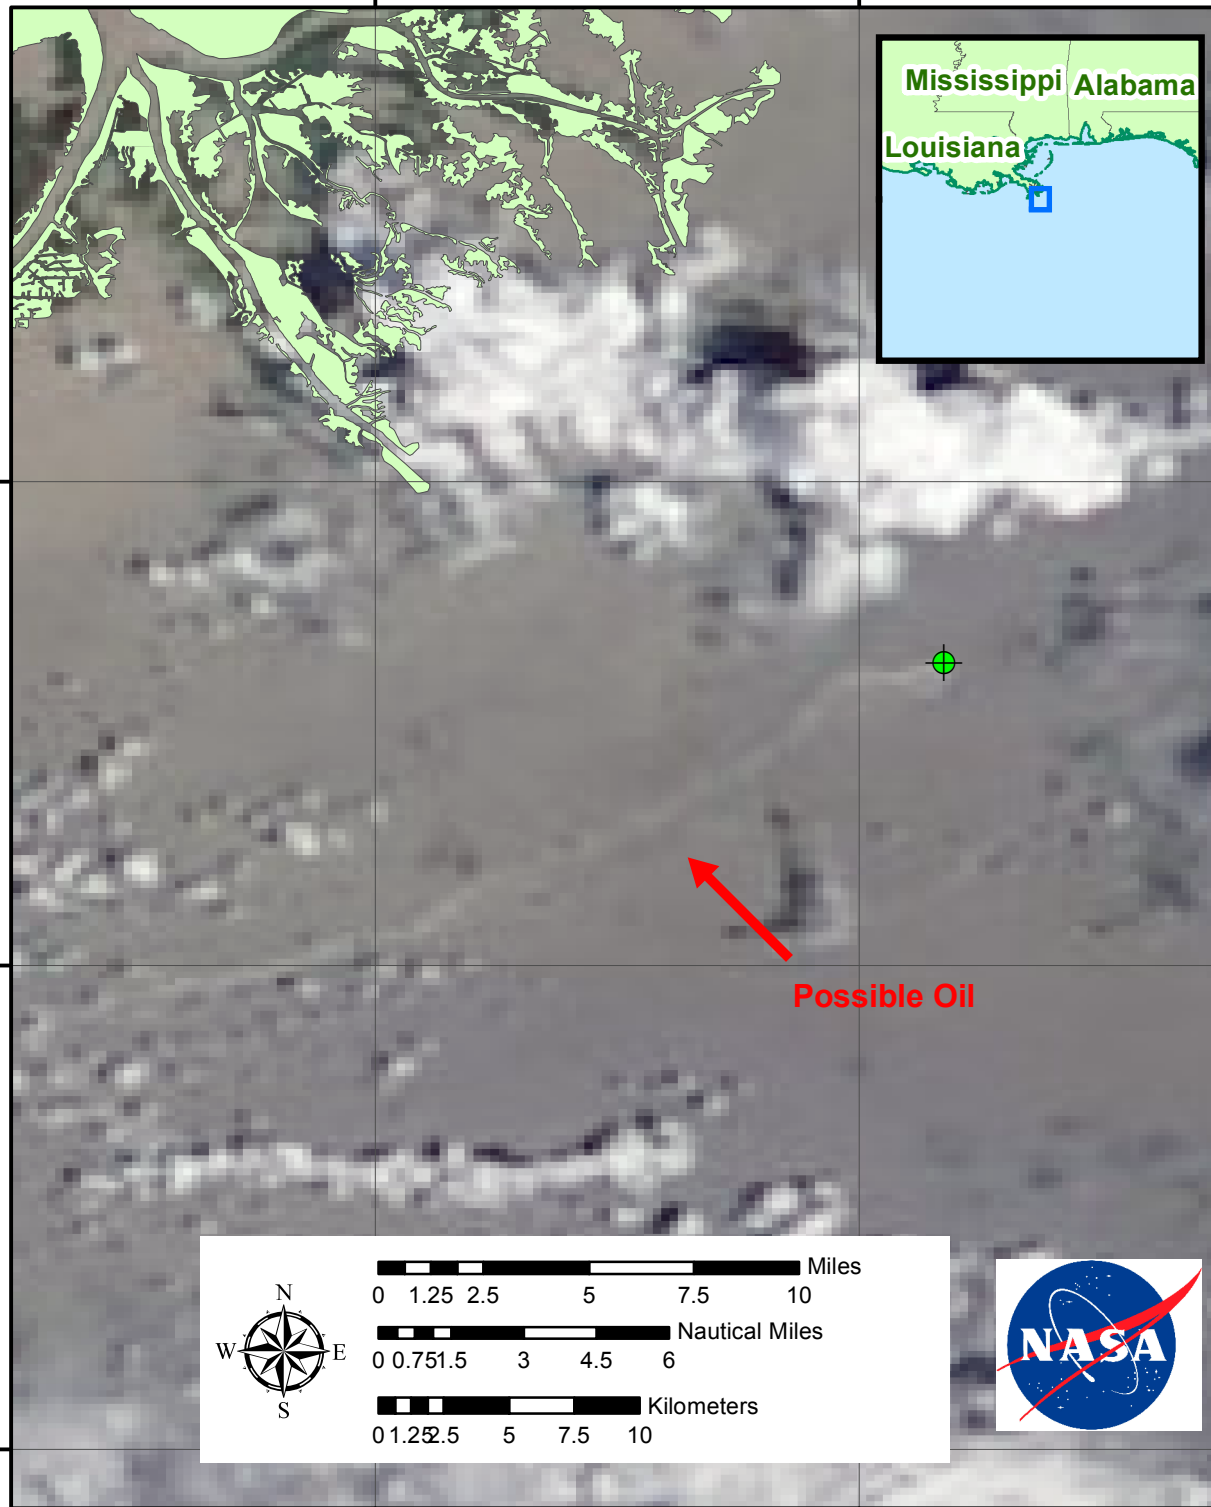
Area of Possible Oil

CONFIDENCE: High

Oil slick emanating 18.5 miles WSW from a known leak
site within Mississippi Canyon block 20. Width of the
slick varies from 0.75-1.0 miles. Confidence is high as
suspected oil appears bright and shimmery in the
sunglint, and because it is easily distinguishable from the
ocean background and weather clouds in the vicinity.
