MARINE POLLUTION SURVEILLANCE REPORT

Analysis Provided by: The National Oceanic and
Atmospheric Administration/National Environmental
Satellite, Data and Information Service (NOAA/NESDIS)

REPORT DATE: AUGUST 31, 2015
REPORT TIME: 2106Z (1606 CDT)
ANALYST: RAMIREZ

DATA SOURCE: TERRA MODIS
MODE: Multispectral
RESOLUTION: 250 meter
IMAGE DATE/TIME: 8/31/2015 1700Z (1200 CDT)

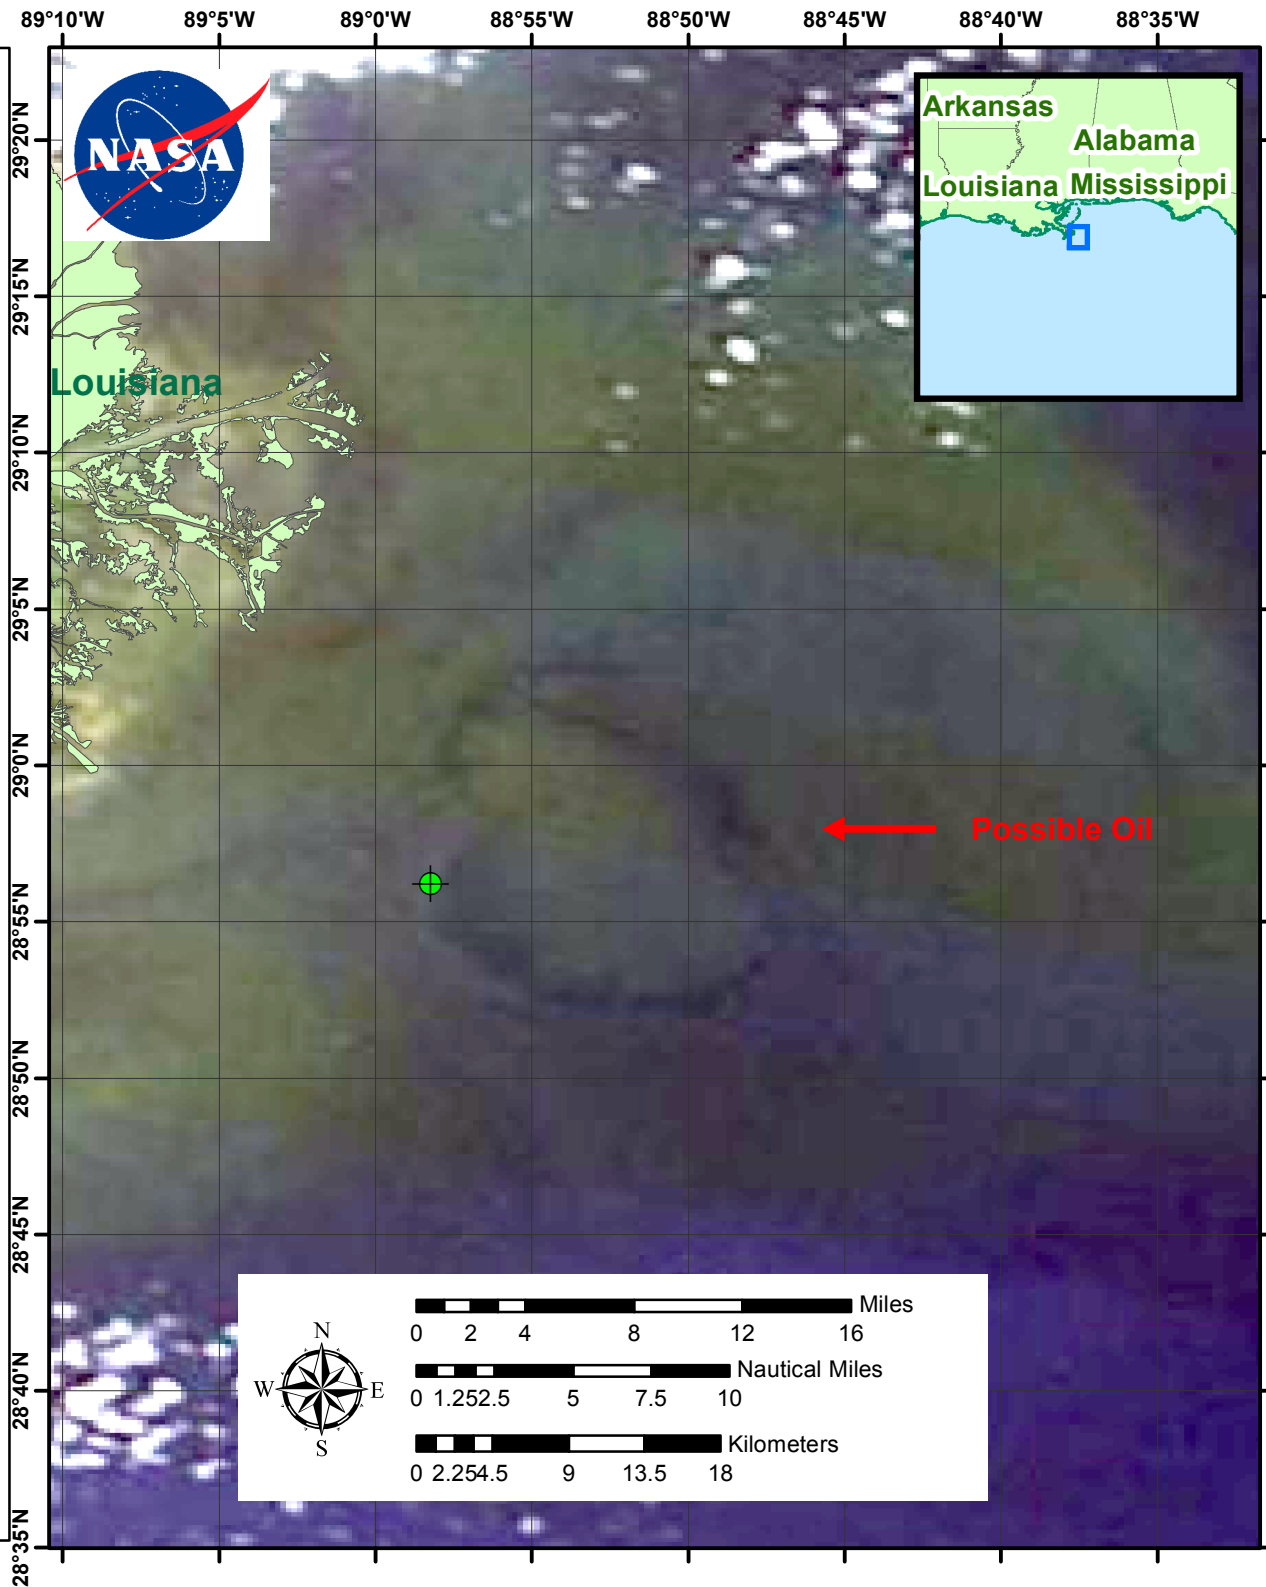
Destroyed Taylor Platform :
[28°56'9" N / 88°58'12" W]
-

200 km² Area of Possible Oil

CONFIDENCE: High

Anomaly is connected to the Destroyed Taylor Platform, a repeat leak source. Anomaly is dark in color which is consistent with the appearance of oil in non sunlint conditions. The suspected oil initially extends to the southeast of the source, then curves north and continues to wrap around, nearly making a complete circle. The circumference is 35 miles. Winds are light and variable at the time of the image.
