# MARINE POLLUTION SURVEILLANCE REPORT

Analysis Provided by: The National Oceanic and  
Atmospheric Administration/National Environmental  
Satellite, Data and Information Service (NOAA/NESDIS)

REPORT DATE: DECEMBER 09, 2015  
REPORT TIME: 2300Z (1700 CST)  
ANALYST: BOLL

DATA SOURCE: LANDSAT-7 ETM+  
MODE: Multispectral  
RESOLUTION: 30 meter  
IMAGE DATE/TIME: 12/9/2015 1627Z (1027 CST)

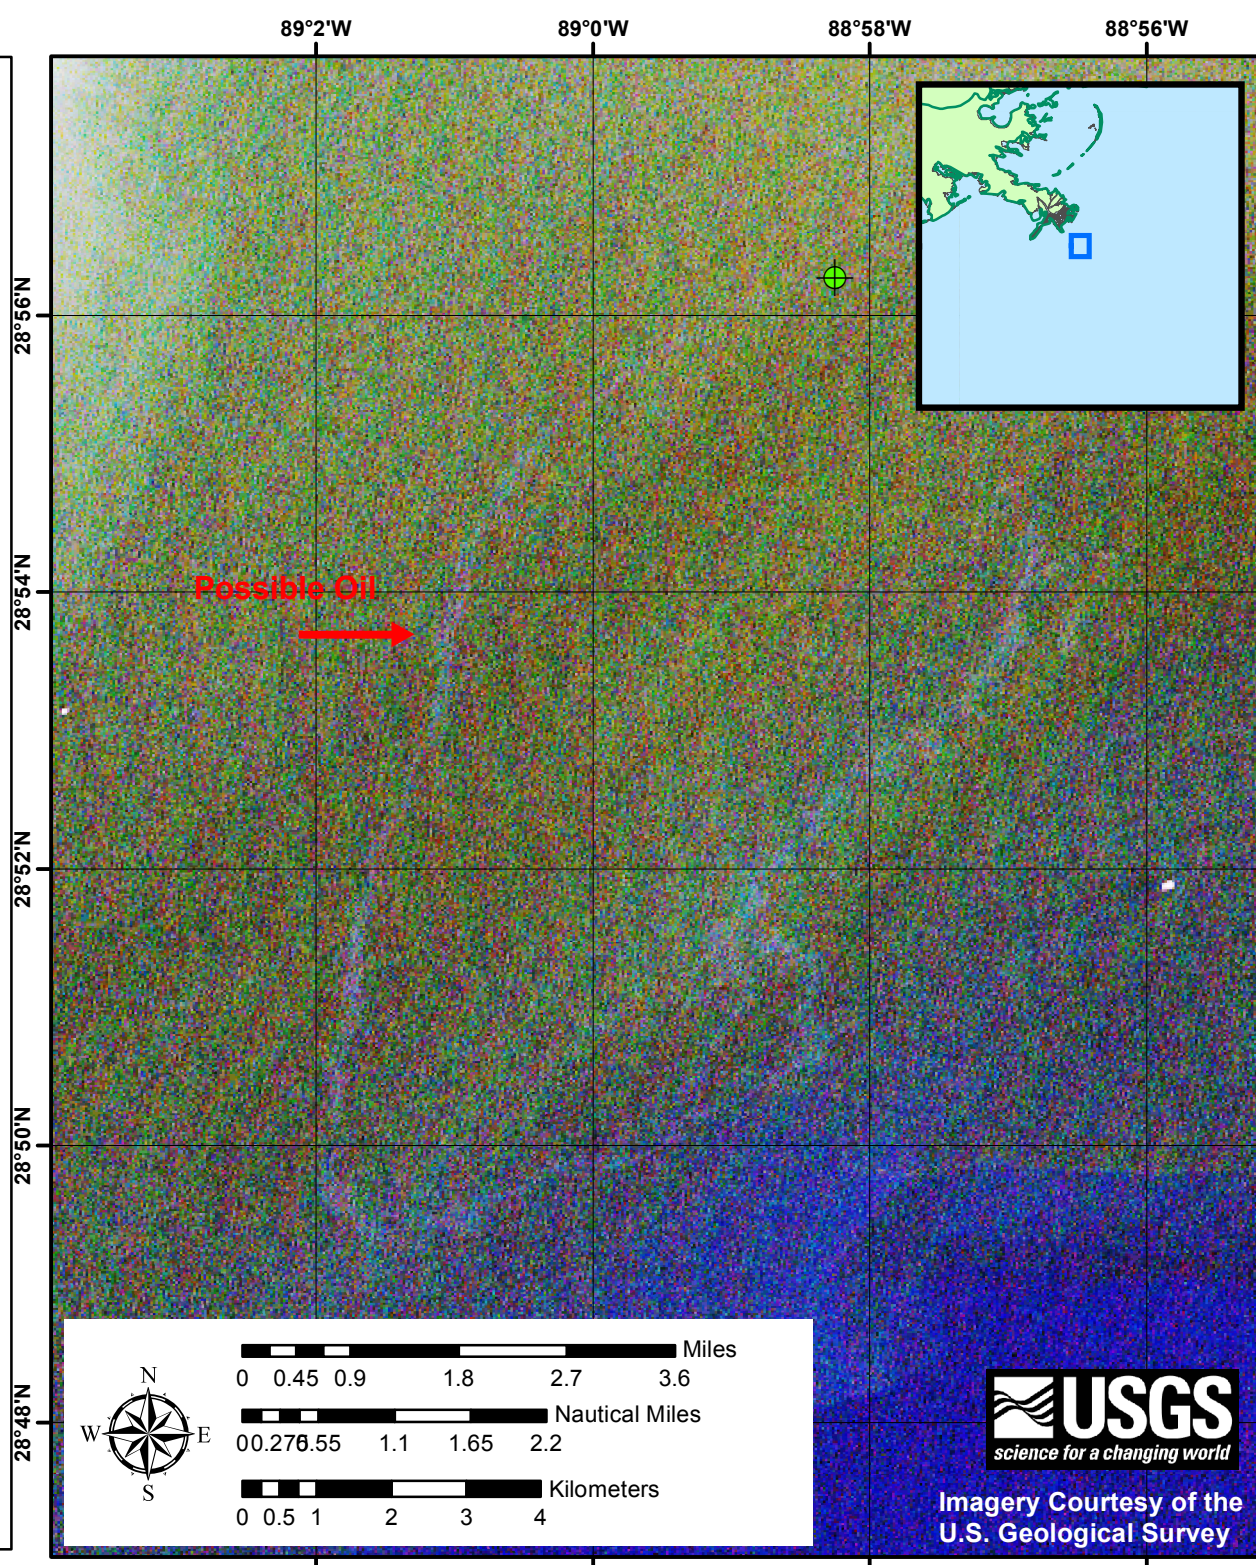
9.3 km<sup>2</sup> Area of Possible Oil

**CONFIDENCE: Medium-High**

A meandering anomaly extended 20 NM from a known repeat leak source. An outline of a suspected sheen was observed with an approximate width of roughly 0.2 NM.

Wind speeds at the time were 5 knots and variable. Modeled ocean currents were under 0.5 knots.

Confidence is Medium-High given the location to a known repeat leak source within the vicinity. The surroundings are homogeneous and the anomaly appears out of place.
