# MARINE POLLUTION SURVEILLANCE REPORT

Analysis Provided by: The National Oceanic and  
Atmospheric Administration/National Environmental  
Satellite, Data and Information Service (NOAA/NESDIS)

REPORT DATE: JUNE 09, 2015

Destroyed Taylor Platform :  
[ 28°56'9" N / 88°58'12" W ]
-

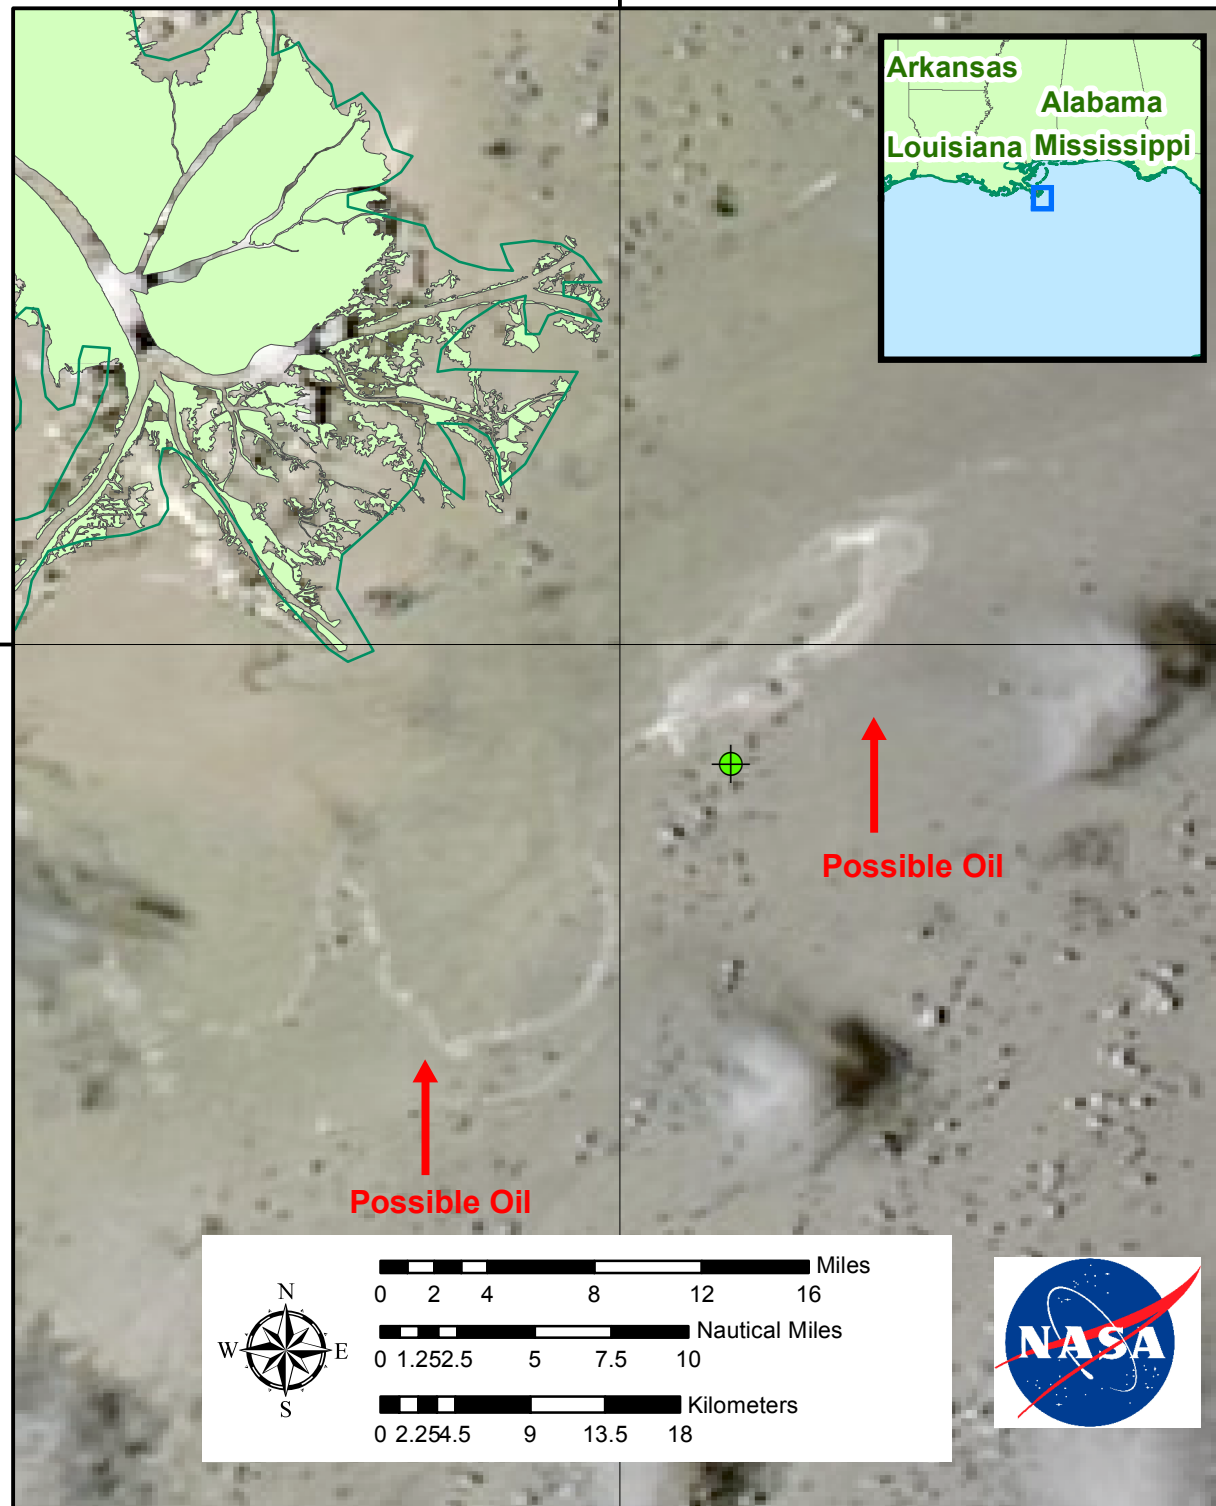
Area of Possible Oil

The possible oil appears to be from a repeat leak source.  
The winds in the area match with the orientation of the oil  
slick and are at 5-10 knots. Cloud cover is relatively  
clear in the area. The possible oil slick to the north is 12  
miles long and to the south is 25 miles long.
