MARINE POLLUTION SURVEILLANCE REPORT

Analysis Provided by: The National Oceanic and
Atmospheric Administration/National Environmental
Satellite, Data and Information Service (NOAA/NESDIS)

REPORT DATE: SEPTEMBER 20, 2015
REPORT TIME: 2246Z (1746 CDT)
ANALYST: RAMIREZ

DATA SOURCE: LANDSAT-7 ETM+
MODE: Multispectral
RESOLUTION: 30 meter
IMAGE DATE/TIME: 9/20/2015 1625Z (1125 CDT)

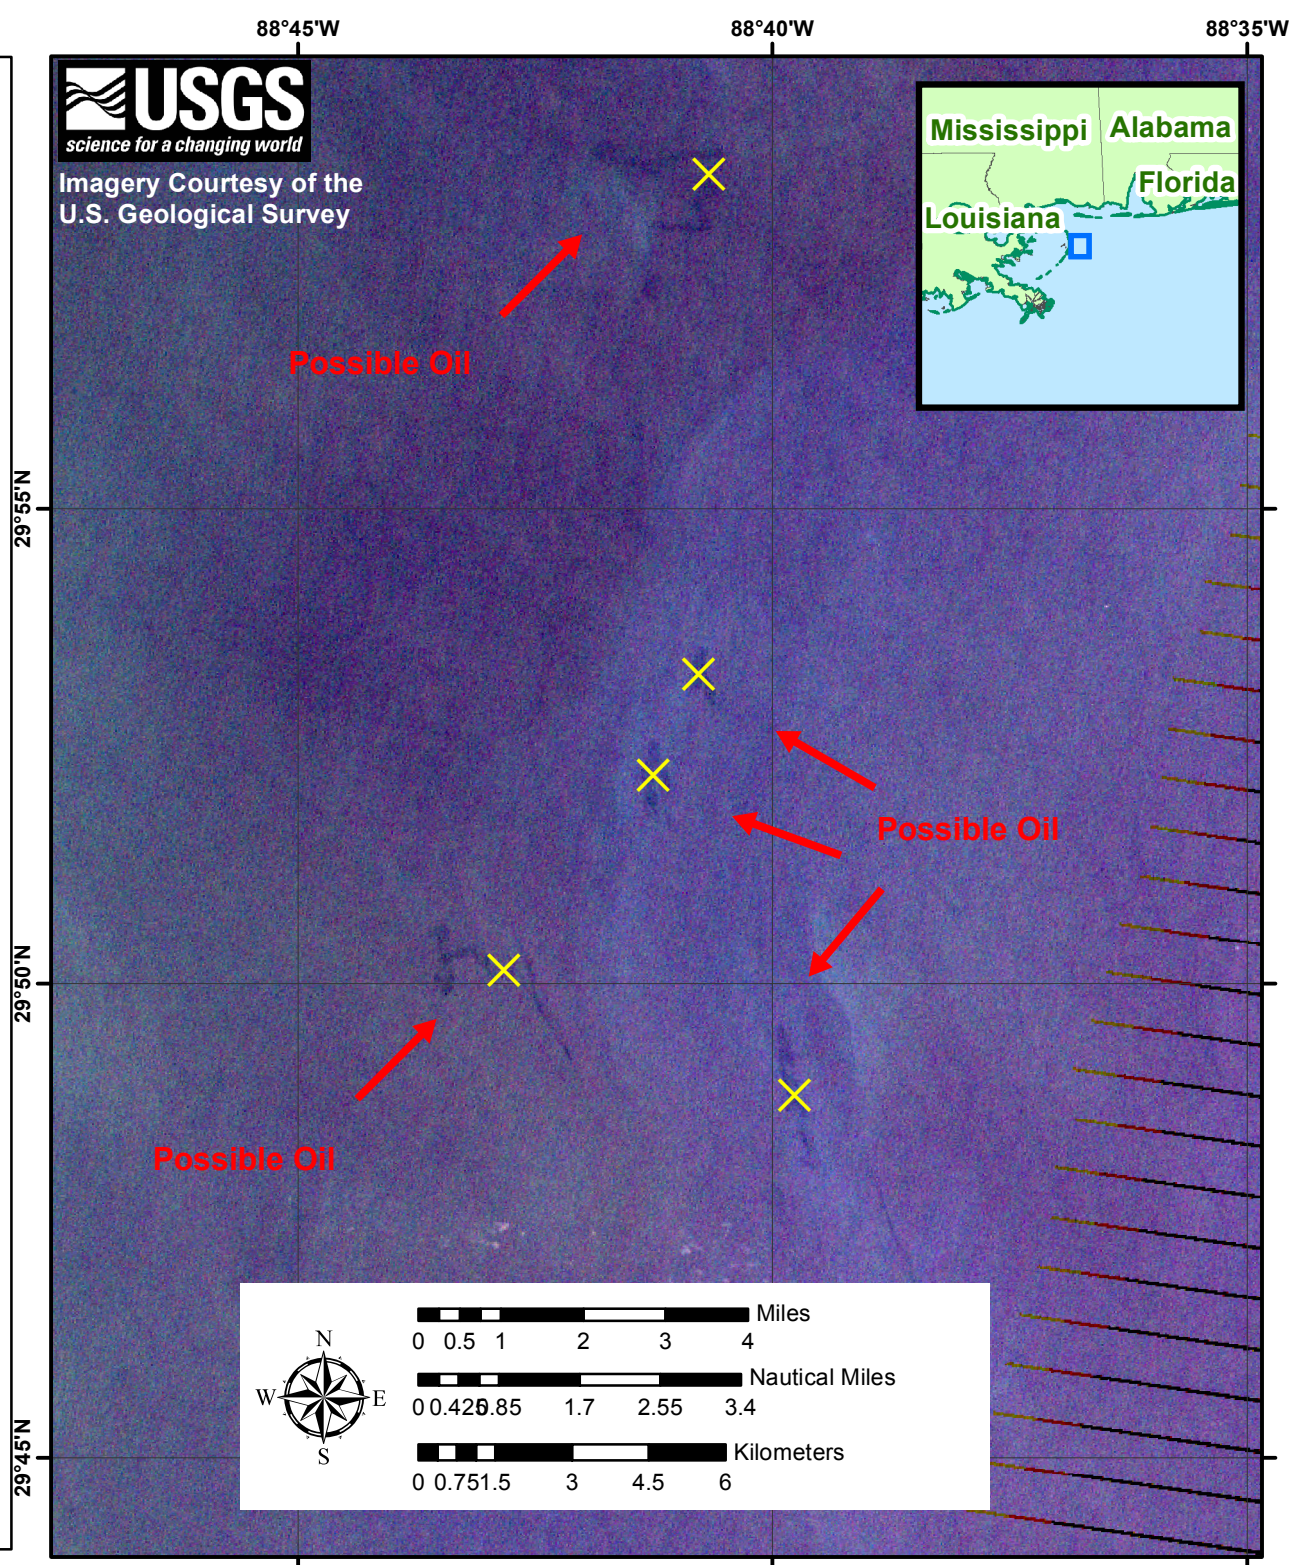
Center Points of Oil Slick (N to S):
[29°58'32" N / 88°40'41" W]
[29°53'17" N / 88°40'46" W]
[29°52'10" N / 88°41'16" W]
[29°50'07" N / 88°42'49" W]
[29°48'51" N / 88°39'47" W]

CONFIDENCE: Medium-High

The five anomalies are suspected to be oil because they are distinct compared to the ocean background, they do not test positive for vegetation (chlorophyll), they exhibit sharp turns, and they are amidst several oil borehole locations. Two, possibly three of the five anomalies are connected to oil boreholes. I have medium high confidence that these anomalies are oil, but am less certain of their origin.
